October 31, 2008

Re: East Chop Bluff (CLE No. 08.057.100, D&A Job No. 0193.022.00)

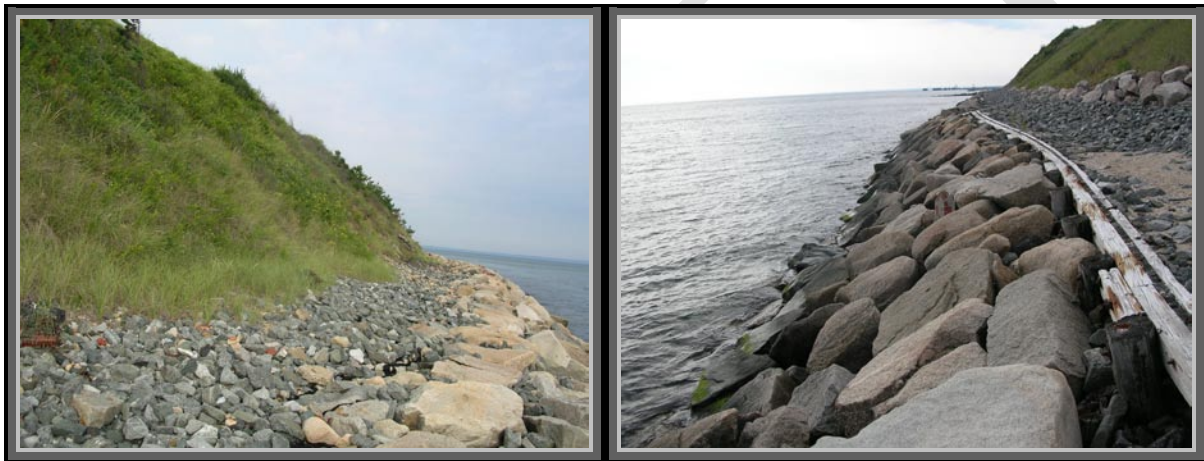
The coastal bank in question runs parallel to East Chop Drive and consists of a 20 to 40 foot high (upper) slopes that dip downward to the north at a 36 to 37 degree angle. The majority of the slope is covered in vegetation (beach grass, *Rosa rugosa*, brush, etc.) and asphalt/concrete debris. At the toe of the slope is 13.5 to 20 foot wide bench made of light riprap. The east half of the bench ends at an old wooden seawall that has been partially buried by a wave break made of heavy riprap. The old seawall was not observed on the western half of the bench. The wave break dips downward to the north at 18 to 41 degrees. See the following photographs for examples of these features.

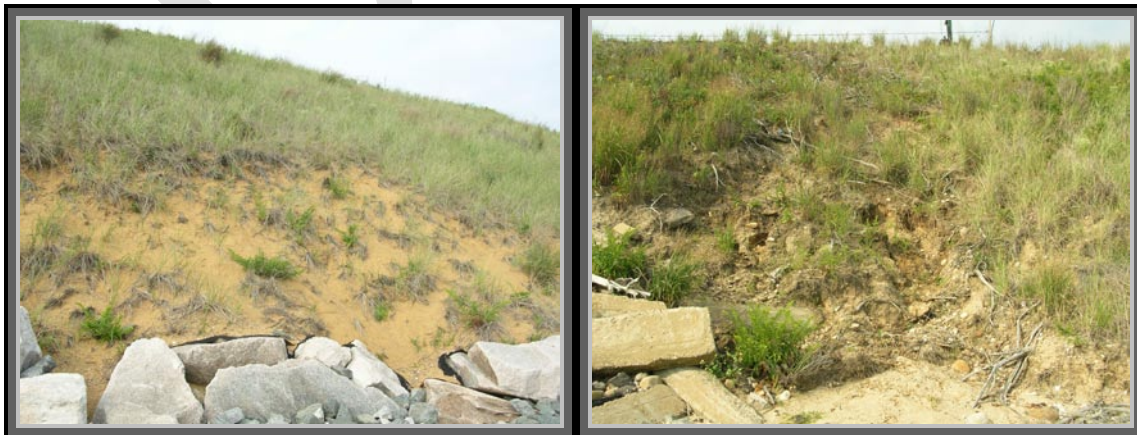
The bench and wave break appear to be in fair condition. The upper vegetated slope of the bank is in poor condition. Numerous scarps, sloughs, and eroded gullies were observed along the length of the slope. Numerous locations of the slope are bare of vegetation. Example photos of distressed areas are shown below.

The East Chop Bluff must be flattened and protected against wave action in order to protect East Chop Drive from being compromised. The following are several options that are available for reducing the slope and providing erosion protection:
