# **INDOOR AIR QUALITY ASSESSMENT**

**Tisbury School  
Little White House (Modular Building)  
40 W William St,  
Vineyard Haven, MA**

Prepared by:  
Massachusetts Department of Public Health  
Bureau of Environmental Health  
Indoor Air Quality Program  
June 2019

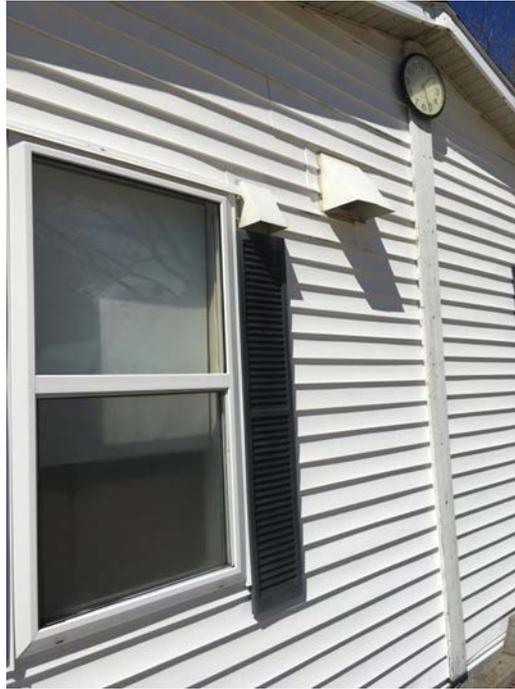
**Picture 1**

Ventilation in the modular classrooms is provided by one air handling unit (AHU), which was deactivated at the time of the assessment. Fresh air intake and exhaust vents are located on the south exterior wall (Picture 1).

As previously mentioned, the AHU was deactivated during the assessment, resulting in no source of mechanical ventilation for the building.

**Fresh air supply and exhaust vent for AHU**

1. Operate supply and exhaust ventilation continuously in all areas during occupied periods. Ensure all HVAC equipment is cleaned/maintained in accordance with manufacturer's instructions.

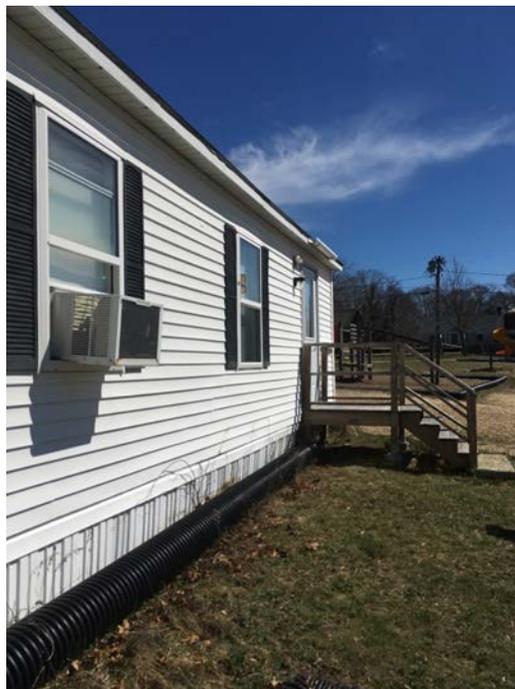
**Picture 2**

- The roof of the modular building does not have gutters and downspouts along the edge of the roof except for entrances (Picture 2).
- The modular building was partially installed on a slope, which directs rainwater under the building. Over time, rainwater has compacted the soil below exterior walls, creating troughs in which water may accumulate against the exterior wall and pool beneath the modular structure.

- The accumulation of water at the base of the modular building causes chronic wetting of the exterior wall. Downspouts should be designed to direct rainwater away from the base of the exterior walls to prevent rainwater from penetrating beneath the building. Wetting of exterior walls and soil beneath the building can result in mold growth.

**No gutter/downspouts along entire roof edge**

3. Repair the skirting around the building.
4. Consider installing gutter and downspout system to drain water away from the building.
5. Examine for means to regrade the soil around the building to drain water away from the building.

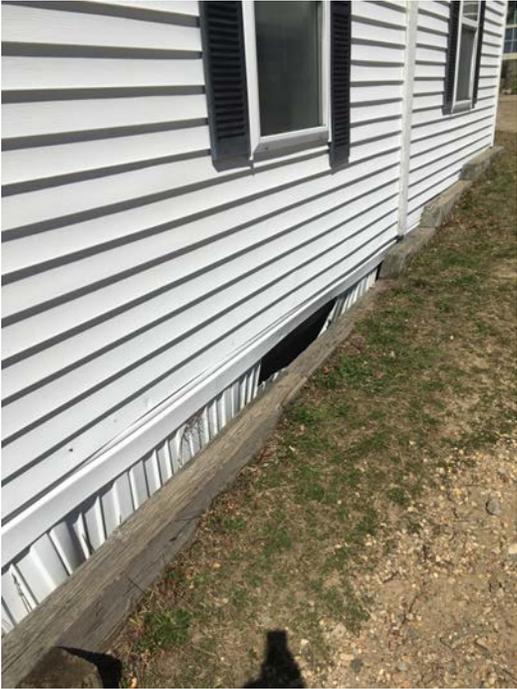
**Picture 3**

- The rear of the building has large holes in its skirting (Picture 3). The prevailing winds in Massachusetts tend to be from the west. Moist weather tends to travel in a northeasterly track, up the Atlantic Coast towards New England (Trewartha, 1943). Wet weather systems generally produce south/southwesterly winds. Driving rain is most likely to strike this door during wet weather patterns which can inject water under the building through the skirting holes.

**Hole in skirting**
