INDOOR AIR QUALITY ASSESSMENT

**Tisbury School
40 West William Street
Vineyard Haven, Massachusetts**

Prepared by:
Massachusetts Department of Public Health
Bureau of Environmental Health
Indoor Air Quality Program
June 2019

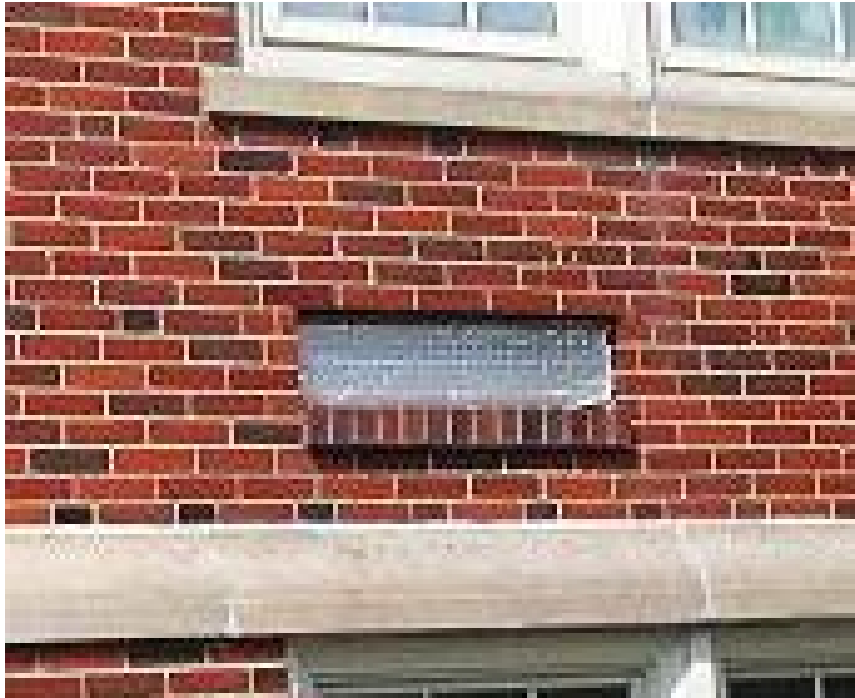
Picture 1

Fresh air in classrooms is supplied by a unit ventilator (univent) system ([Figure 1](#)). Univents draw air from outdoors through a fresh air intake located on the exterior walls of the building (Picture 1) and return air through an intake located at the base of each unit. Fresh and return air are mixed, filtered, heated and provided to classrooms through an air diffuser located in the top of the unit. Univent fresh air intakes throughout the building were sealed (Picture 1). By sealing the fresh air intakes, no mechanical source of fresh air exists. Each classroom was originally equipped with exhaust ventilation, which would vent normally occurring indoor pollutants from the room, and in combination of the operation of a fully functional univent, create airflow. Exhaust vents in classrooms were sealed (Picture 2) and repurposed for use as cable runs for computers. Based on this condition, the TS does not have a functional source of fresh air supply or exhaust ventilation. All univents provide only heat and recirculate air. Many univents had various materials stored in front of the return vent or on top to block diffusers. Odors from stored materials can become aerosolized by the operation of univents and be irritating to the eyes, nose and respiratory system to sensitive individuals.

Sealed univent fresh air intake

1. In order to provide fresh air, appropriate use of windows at all times during the school years is necessary.
2. Consider contracting with a ventilation engineer to assess the feasibility of restoring the ventilation system to adequate function. Such methods may include:
 - Remove all blockages from univent fresh air intakes.
 - Installing a hood to shelter the intake from direct wind impingement to prevent coil freeze.
 - Improve filtration in univents.
 - Examine the feasibility of restoring the function of all exhaust vents in classrooms, common areas, restrooms and internal rooms.
 - Once mechanical fresh air and exhaust vents are restored to proper function, consider adopting a balancing schedule of every 5 years for all mechanical ventilation systems, as recommended by ventilation industrial standards (SMACNA, 1994).

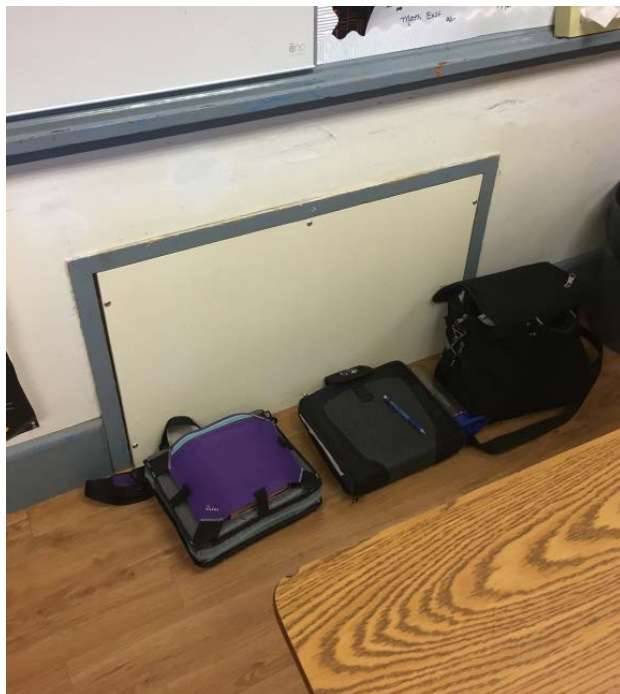
Picture 2

Sealed exhaust vent

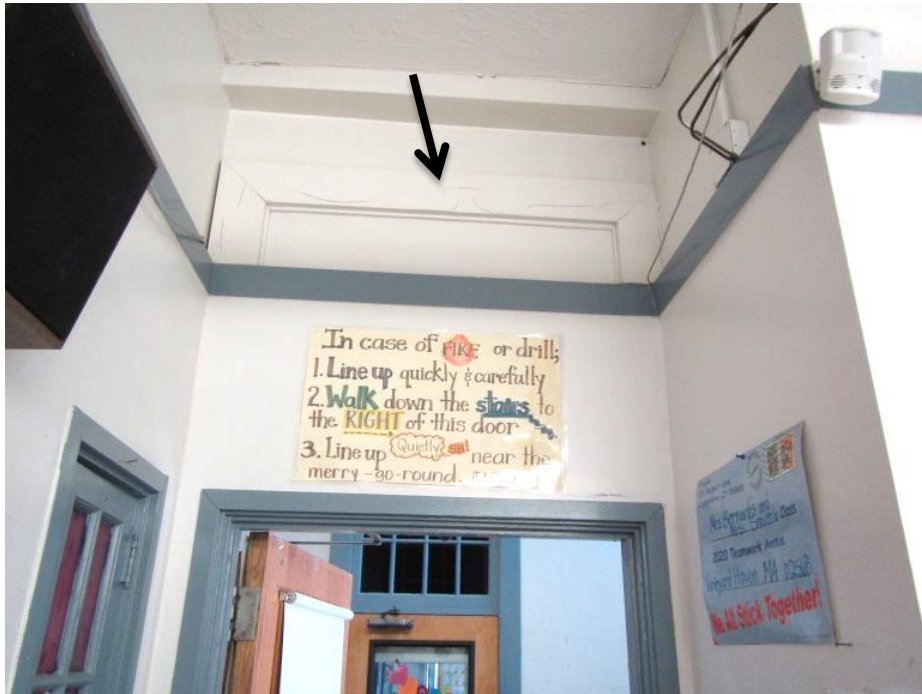
Picture 3

Sealed transom (arrow)

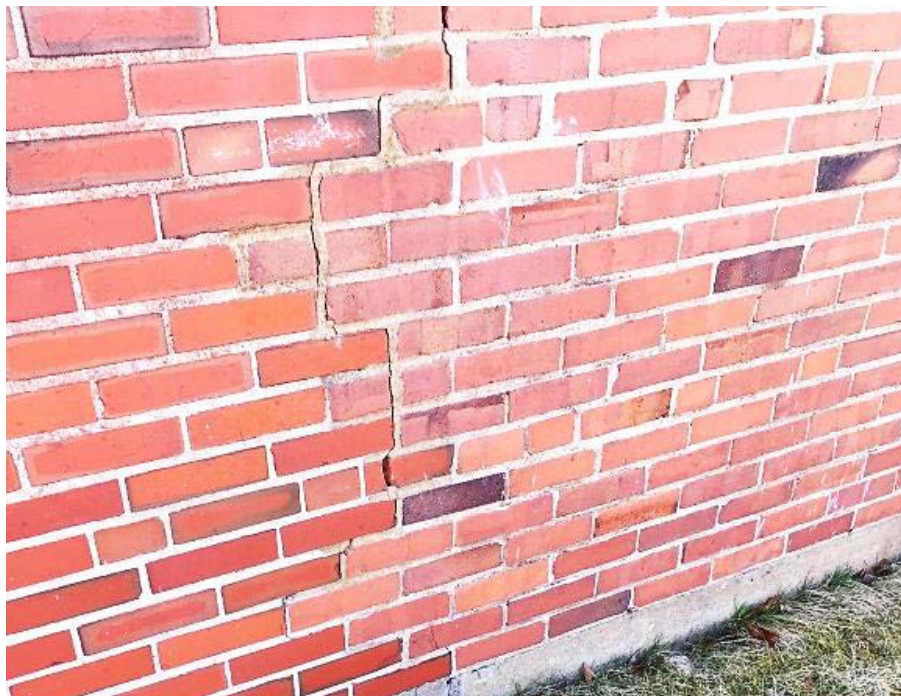
Picture 4

- A section of walls around the gymnasium wing are cracked (Picture 4).
- A window frame in the front of the building has rotted wood and a damaged sill (Picture 5). It appears that spray foam insulation was applied which would hold water behind the window frame and wall cavity. (Spray foam insulation is a water impermeable material that would dam water behind brick and mortar. Brick and mortar are porous materials through which water may pass).

Gymnasium wing exterior wall cracks

- Determine if the sealant is the appropriate method to seal the mortar joints.
 - Determine the extent of mortar repointing necessary for exterior walls around the entire exterior wall.

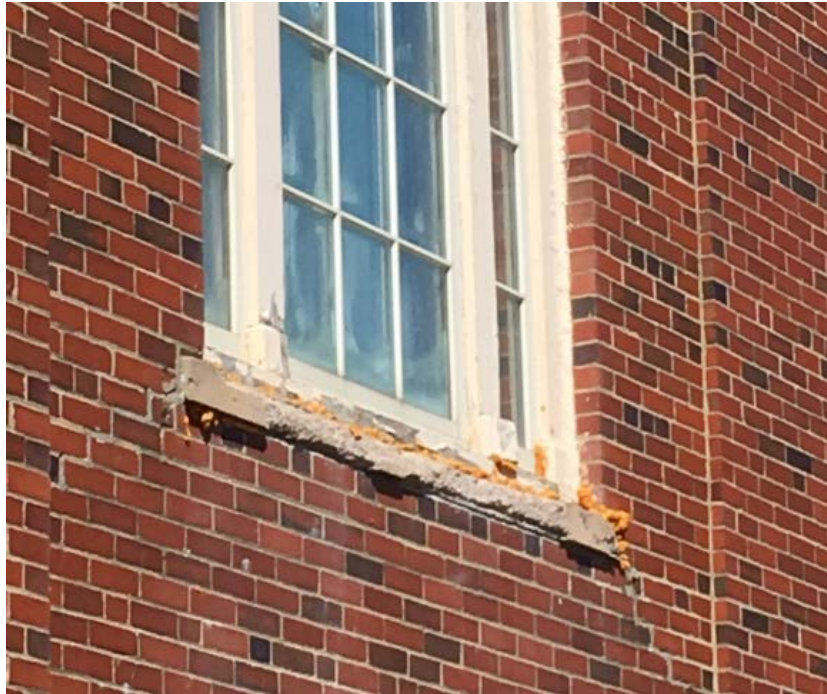
Picture 5

- Condensation on the inside of energy efficient windows indicates that the gaskets have failed, allowing moisture penetration (Picture 5).
- It appears the side entrances to the 1929 wing were reconfigured during the 1993 addition construction (east and west entrances). A significant amount of water-damaged plaster exists in the east entrance. Water damage inside this entrance appears to be directly below the junction of the roof of the east entrance and 1929 building (Pictures 6). The water leak appears to be related to the wall above the east entrance, which likely originally had an awning-shaped roof sheltering this doorway (Picture 7). A line of sealant is visible on the brickwork above the entrance as well as vertical black stains on brickwork flanking the sealant which suggest the removal of such an awning. Of note is a quality of brick called porosity¹. If the bricks used to seal the area above the entrance are more porous than surrounding brick, wind-driven rainwater may pass through the brick to accumulate inside the exterior wall to possibly cause the damage shown in Picture 6.

Damaged window frame and sill with spray foam insulation

4. Remove all stored materials in front of and on top of univents to prevent odor distribution.
5. Remove the spray foam insulation from exterior walls. Repoint with mortar.

6. Repair all wooden window frames.
7. Replace the stone windowsill in Picture 5.
8. Consider having a building engineer:
 - Examine the wall above the east entrance to ascertain whether the brickwork is intact and has appropriate porosity.

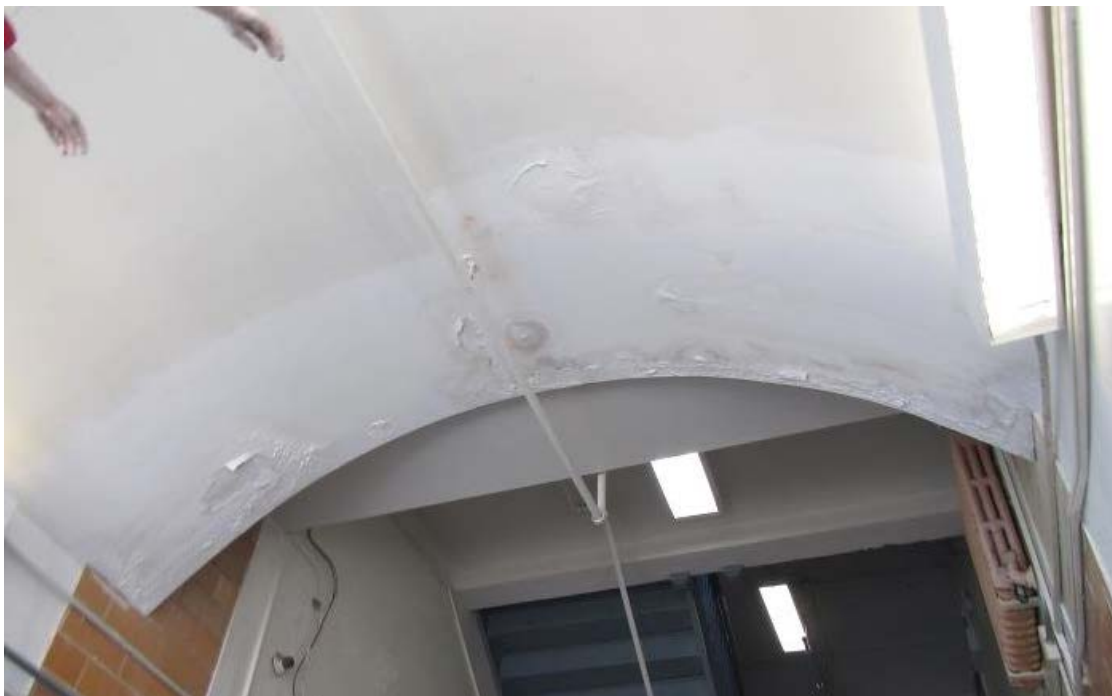
Picture 6

- Water damage inside the east entrance may also be related to the lack of gutters, drip edge or sealant where the entrance roof and wall meets.

Water damage inside the east entrance

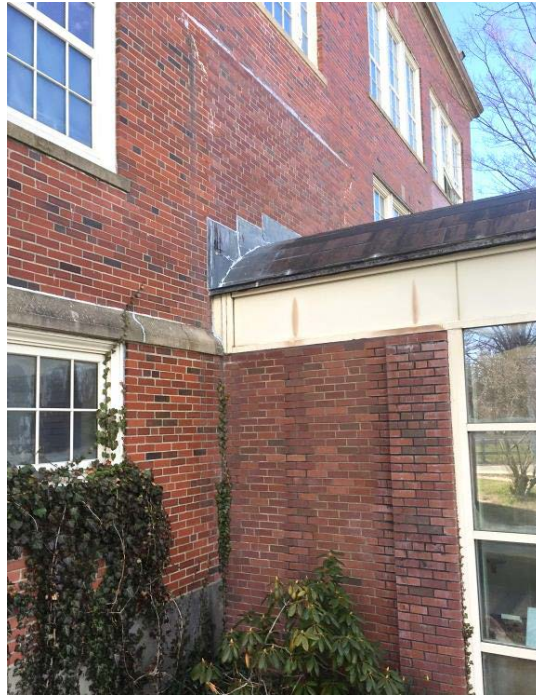
Picture 7

**Sealed opening in brick above the east entrance
(Note sealant and blackened brick above entrance roof)**

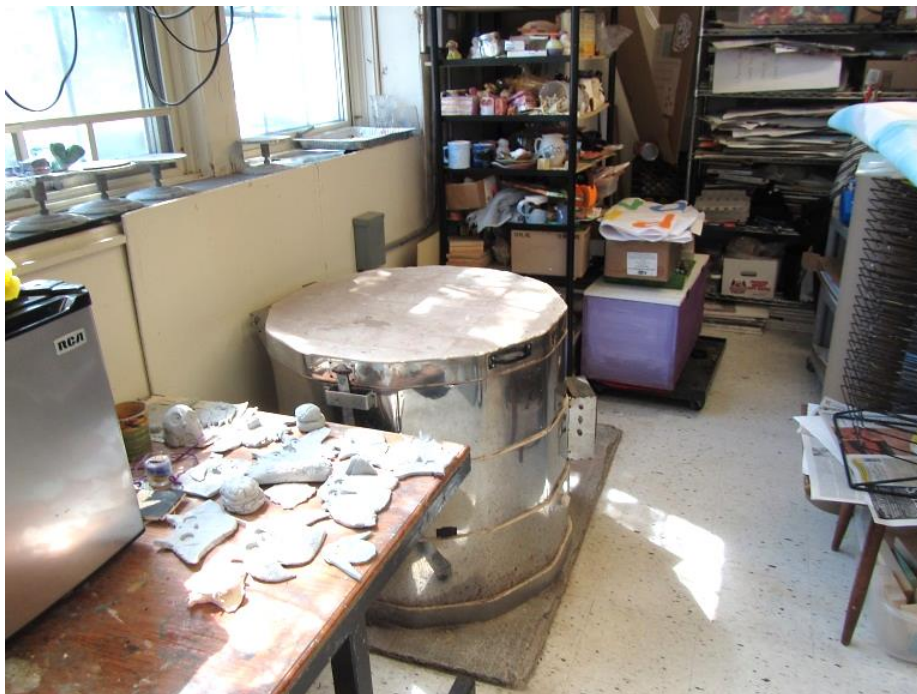
Picture 8

A kiln in the art room had no exhaust ventilation (Picture 8) and was located directly inside the classroom. Exhaust ventilation for kilns is necessary to remove heat and odors during operation. Consider installing a direct exhaust vent for the kiln and ensure it is used every time the kiln is in operation.

Kiln in art room with no dedicated exhaust vent

16. Use photocopiers and laminators in well-ventilated areas.
17. Discontinue use of pottery kiln until proper exhaust ventilation is installed.
18. Consider upgrading to a pleated filter of minimum efficiency rating value (MERV) 8 in univents and AHUs, if these can be used with the current equipment. Change filters 2-4 times a year or as per the manufacture's recommendations.

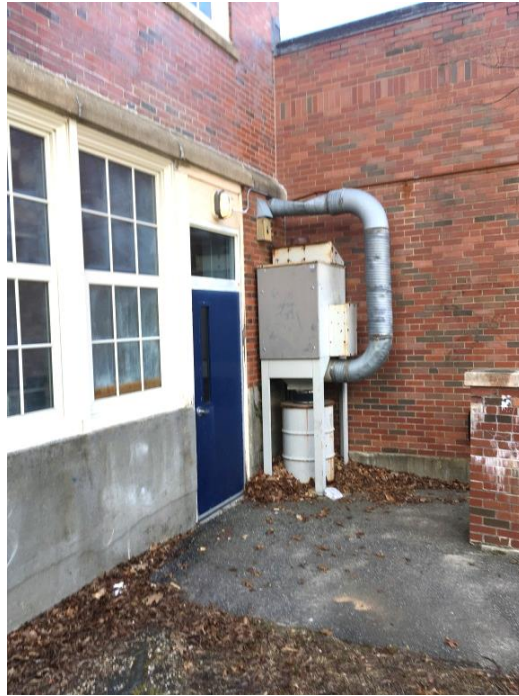
Picture 9

The TS also contains a wood shop, which has a wood dust collector unit (Picture 9). In order for the wood dust collector to work properly, an adequate amount of make-up air is needed to maximize the airflow. Aside from opening windows, no source of make-up air was identified during this assessment.

Wood dust collector

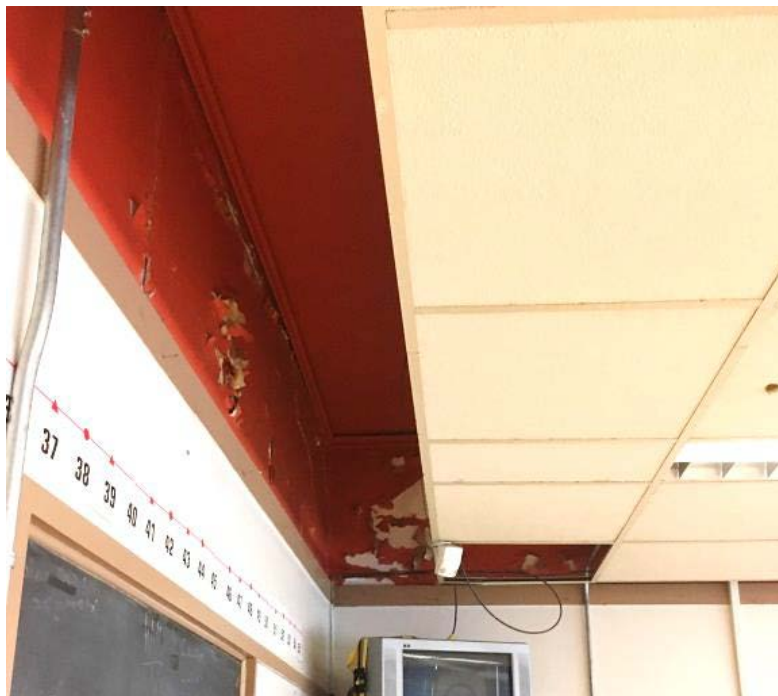
Picture 10

Of note was the presence of peeling paint in a number of locations (Picture 10, Table 1). IAQ staff could not identify whether the paint may contain lead. Given age of the TS, is possible that classroom paint contains lead and would be require remediation in a manner consistent with Massachusetts lead paint laws and regulations.

Example of peeling paint in 1929 wing classroom

22. Determine if peeling paint in the gyms contain lead. If paint contains lead, remove paint in a manner consistent with Massachusetts lead paint laws and regulations. If no lead is present, remove peeling paint.
