# Nauset Environmental Services, Inc.

NES Job #900  
Report No. NES/IAQ-15/1782

Re: Mold/moisture inspection plus reception sampling  
at Tisbury Police Stations – 32 Water Street (Tisbury)

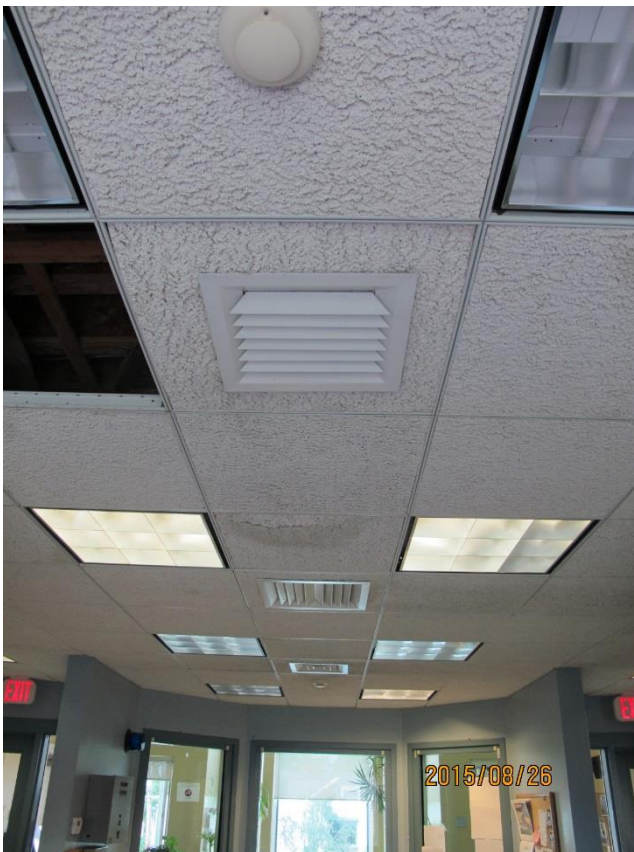
Clean supply grates in reception area

- The supply grates were quite clean at the time of this inspection, almost as if they had recently been wiped clean (see photos), however the return grate showed evidence of collected dirt and had not been recently cleaned. [Clean grates semi-annually.]

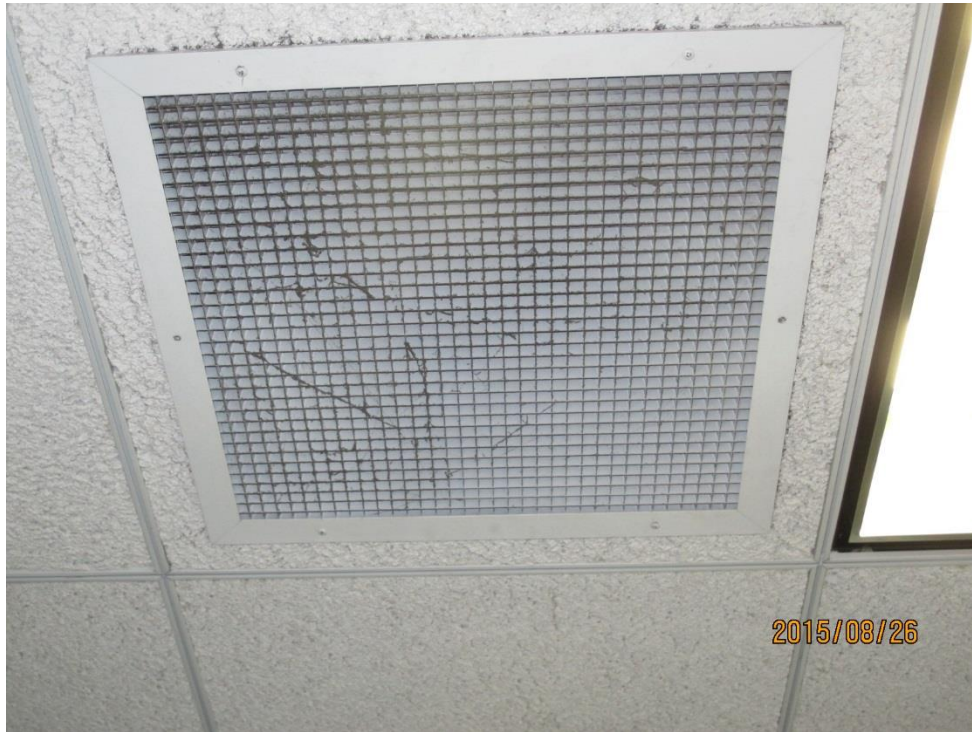
Dirty return grate in reception area

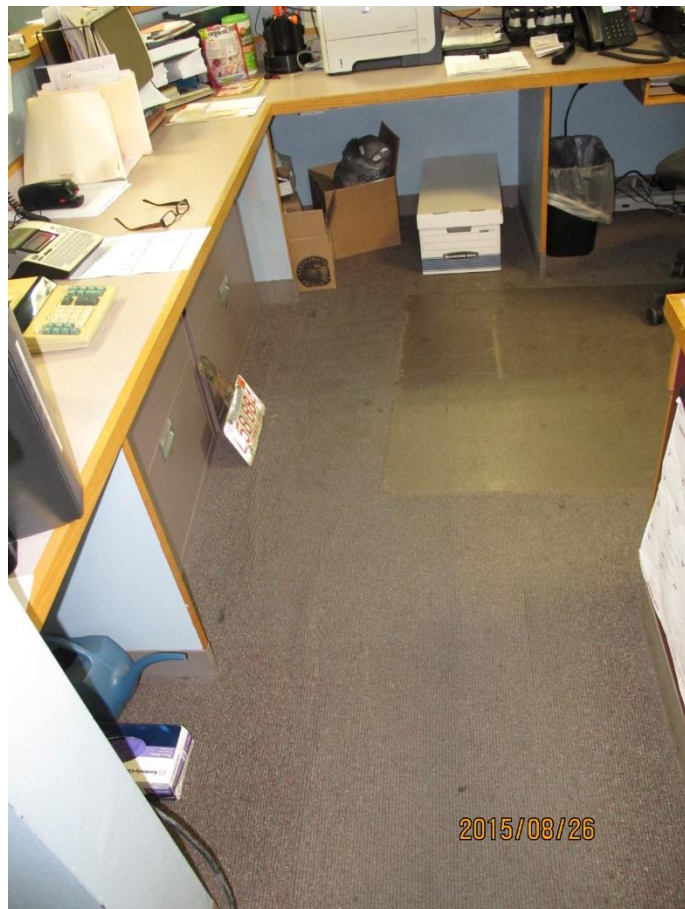
Old, deteriorate carpet in reception area (perhaps contributing to the high debris reading in the air sample)

- She indicated that some visitors to the area also have experienced coughing episodes.
- There was thin and well-worn carpeting in the general reception area (see photo). [See sampling results and related suggestions below.]

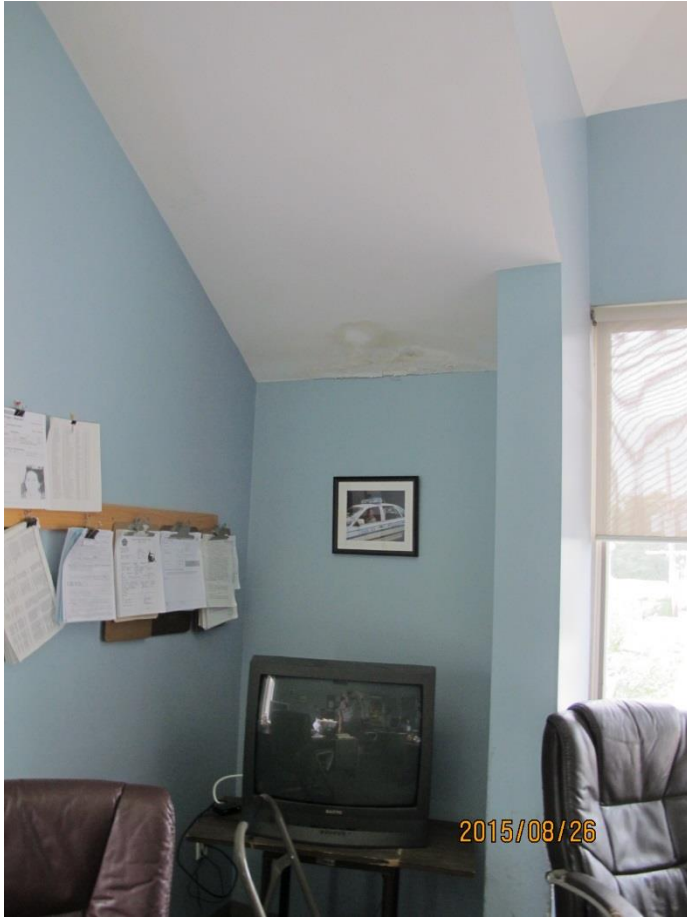
Water-damaged right, front wall (as viewed from the parking lot) in front Officers Room

- When checked with the MM it indicated unacceptably moist conditions in that front ceiling and wall from water seepage:
  - 99% FS-DW on ceiling and vertical wall (see photos). [This observation indicates the possibility of hidden mold growth, Condition 3 contamination, in the wall cavity, calling for serious caution in responding to the damp wall so that potential hidden spores are not released to the occupied area – see SOW below.]

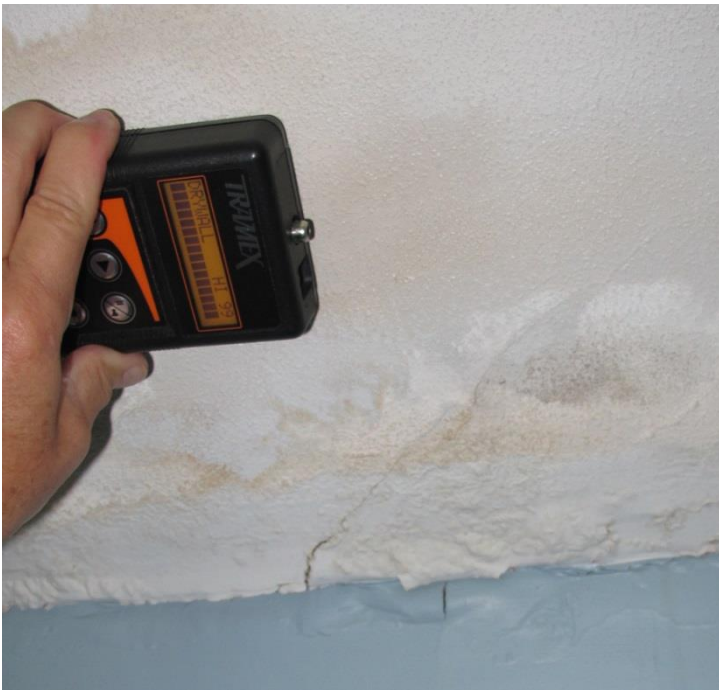
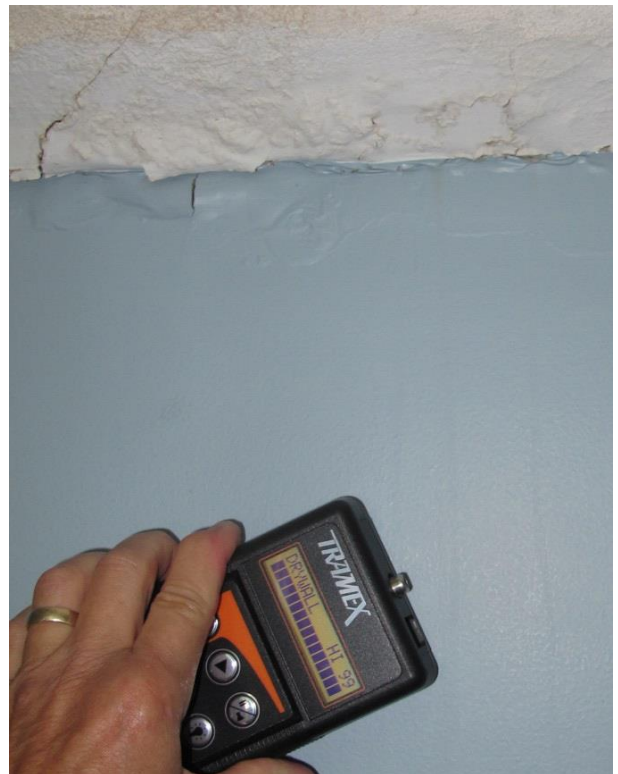
MM readings of 99% FS-DW in damaged ceiling area and wall below

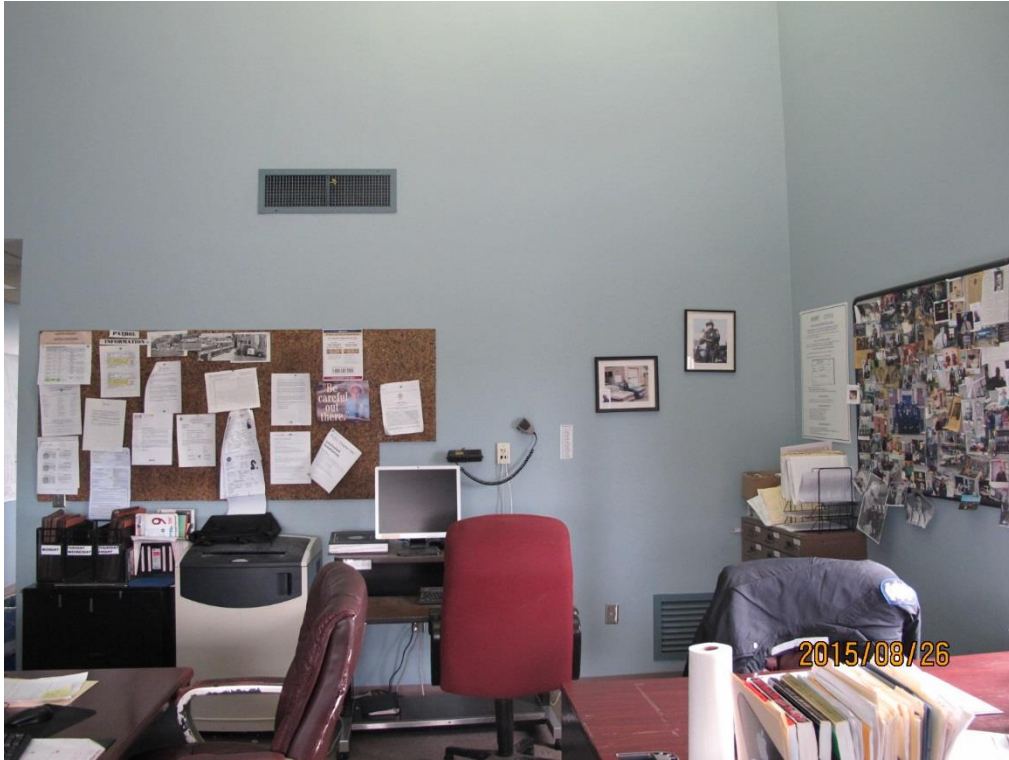
Rear wall in front Officers Room

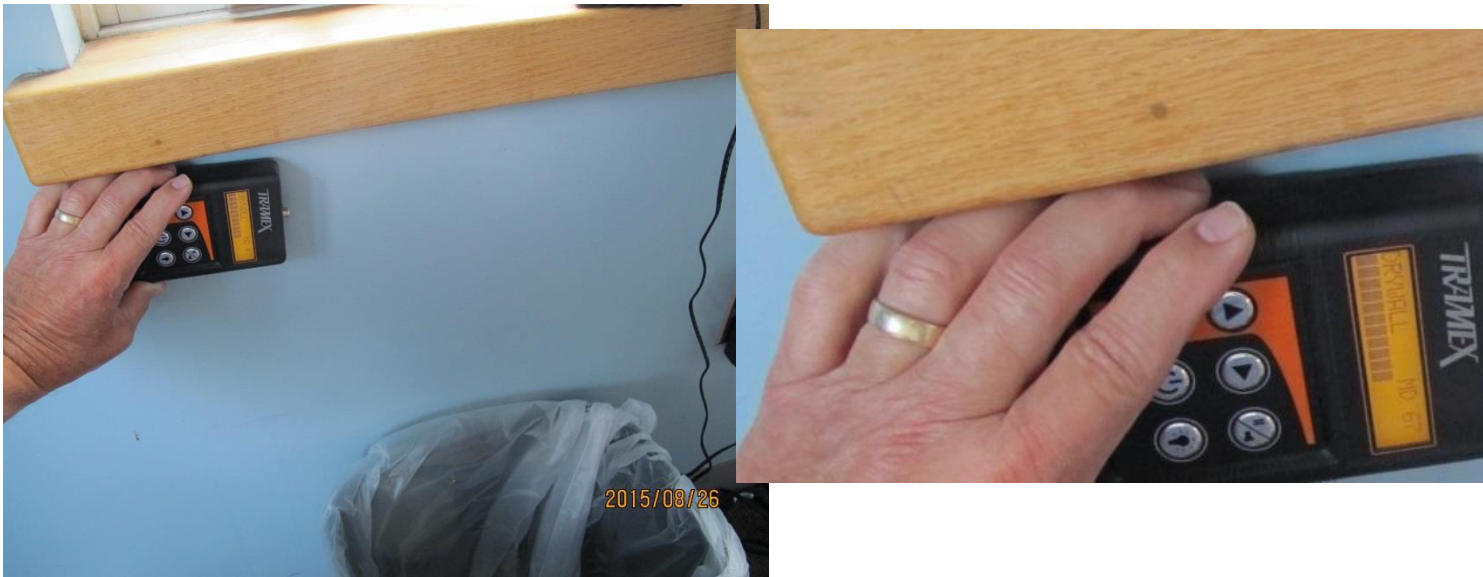
MM reading of 67% FS-DW under lower left corner of rear window in right side wall of rear Officers Room

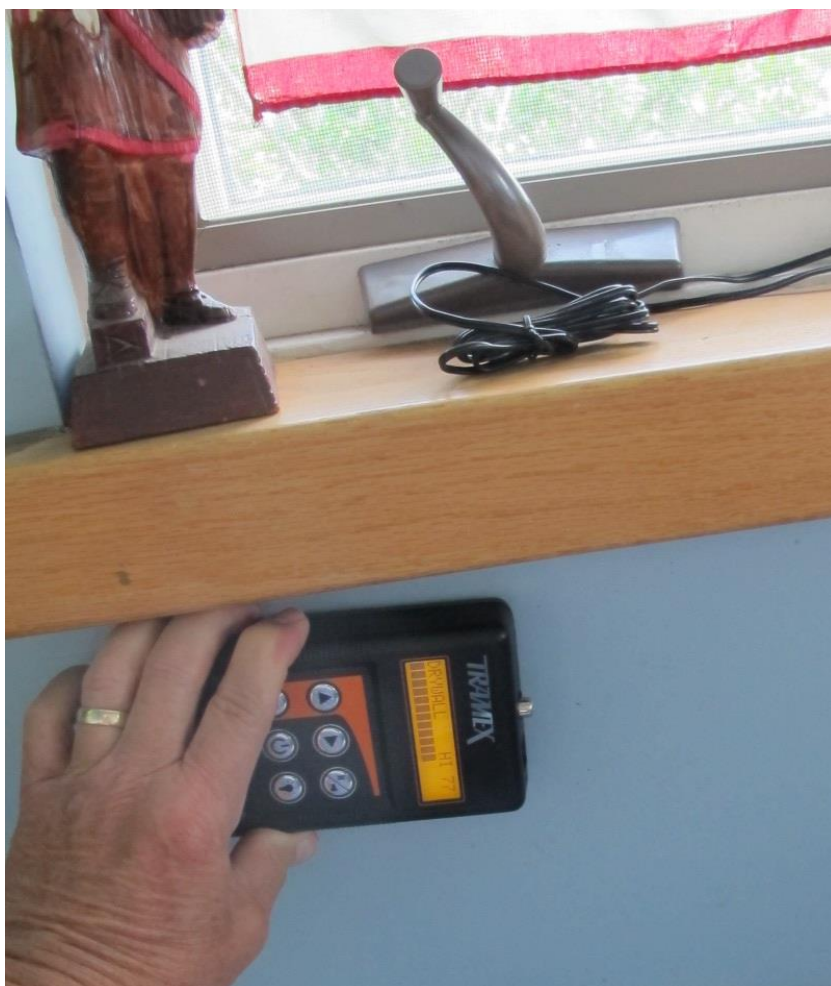
MM reading of 77% FS-DW in lower left corner of rear window in rear Offices Room – a strong indication of moisture penetration

- Grates were clean (see photo).
- The MM indicated the following conditions in the room:
  - 43-55% FS-DW under right side, front window – marginally acceptable
  - 67+% FS-DW at lower left corner of rear window frame (see photo) – suspect for moisture intrusion
  - 30-50% FS-DW under rear window – acceptable
  - 73-75% FS-DW under left corner of rear window (see photo) – NOT acceptable [needs exploration, see SOW below]

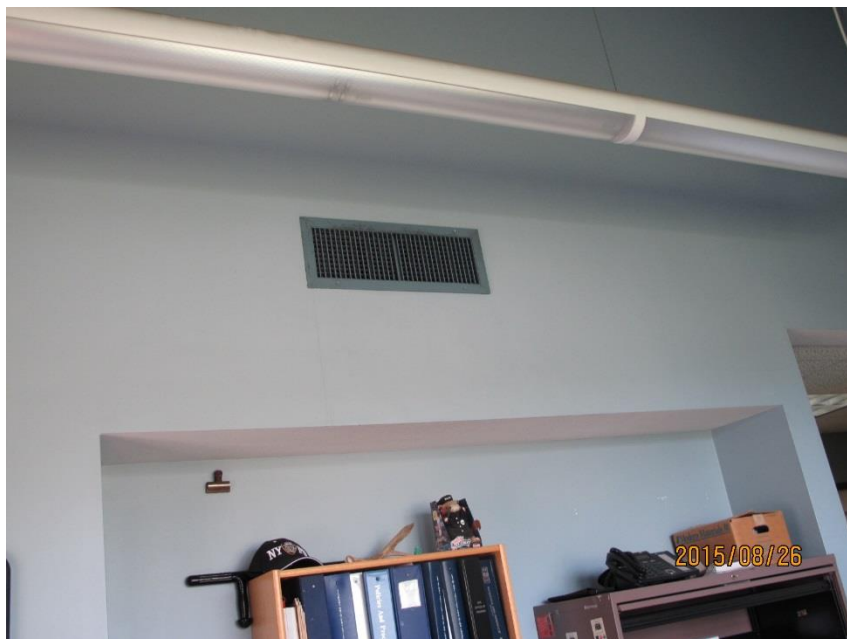
Clean grate in rear Officers Room

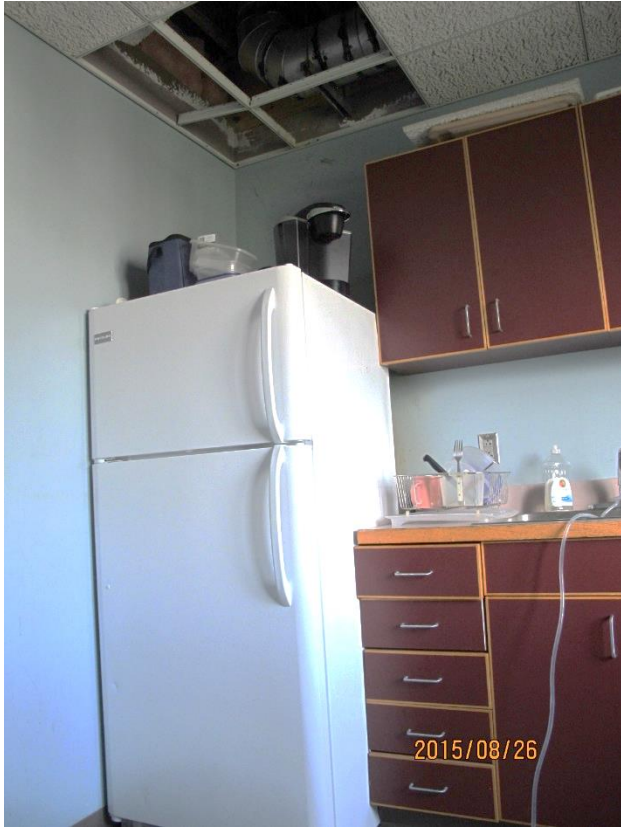
Suspect leak area above ceiling in kitchen

- There is evidence of an above-ceiling leak at the left side of the counter (see photo). [Check to see that it has been satisfactorily corrected and replace DCTs.]
- The MM (moisture meter) indicated acceptably dry conditions under the kitchen window in the range of 30-40% of full scale on the drywall setting (FS-DW).

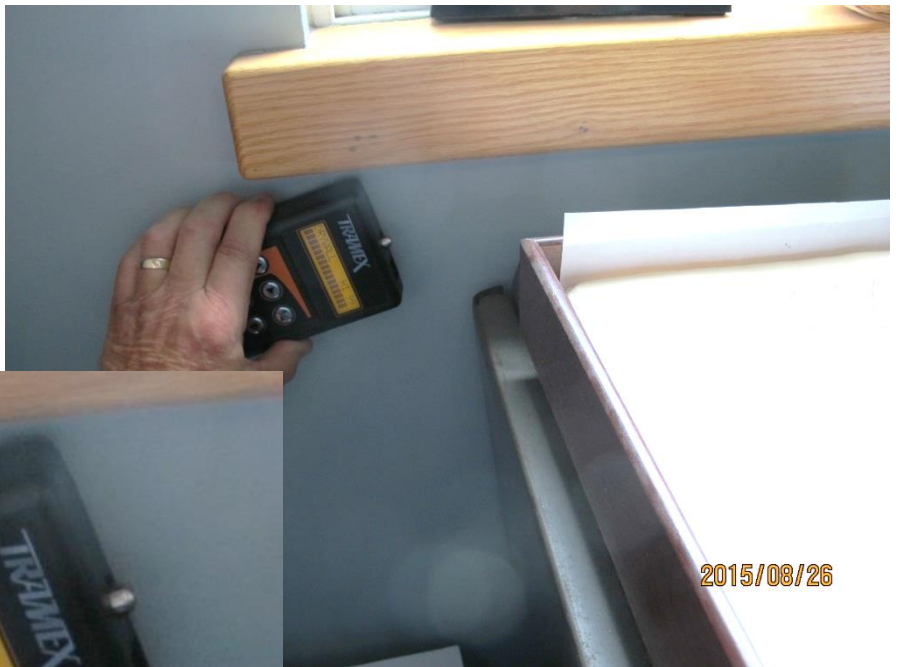
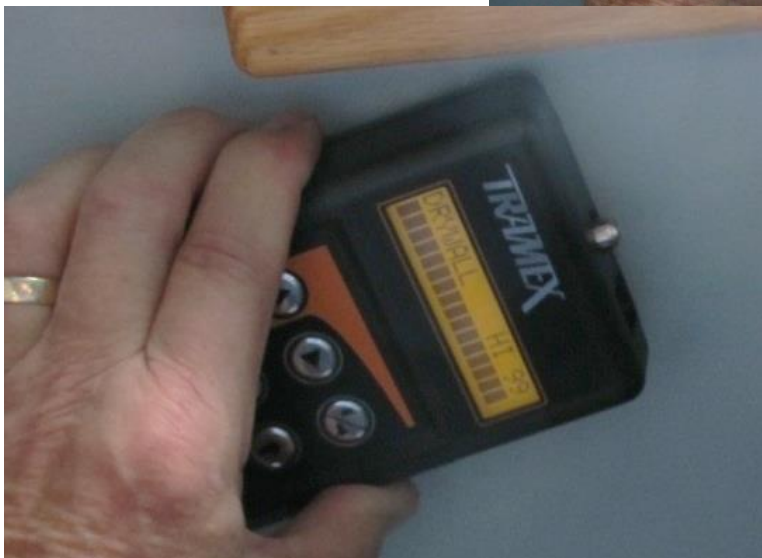
- The MM indicated the following conditions near the copier:
  - 99% FS-DW lower left corner under rear window – NOT acceptable [[needs exploration, see SOW below]

Elevated MM reading of 99% FS-DW under left corner of rear window in reception area indicating water seepage into cavity

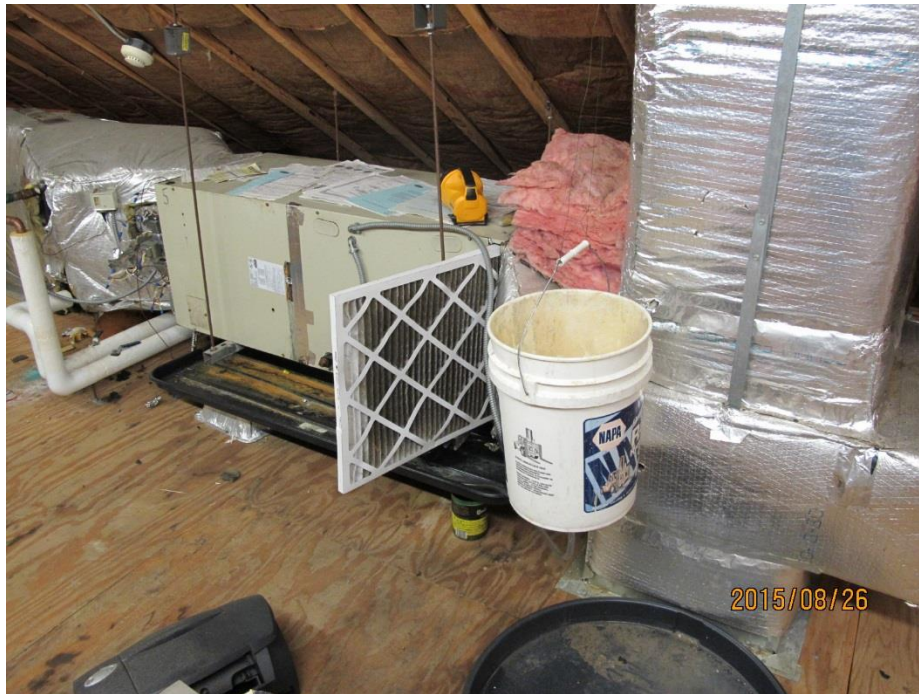
Dirty air filter for middle air handler in attic next to jury-rigged leak trap

- The pleated media filter for the middle air handler was quite dirty (see photo) and needs to be changed. [This filter should be changed quarterly, so a small stockpile should be provided near the unit.]
- There were water stains and signs of leaks near the exhaust stack penetration from this unit and a water collection arrangement directing water into the unit’s drip pan (see photo). MM readings indicated an elevated reading above of 32-33% moisture content (MC) on the nearby joist and sheathing indicating a current leak (see photos). [The roof seal around this penetration should be checked and corrected as well as areas near water staining in the attic.]

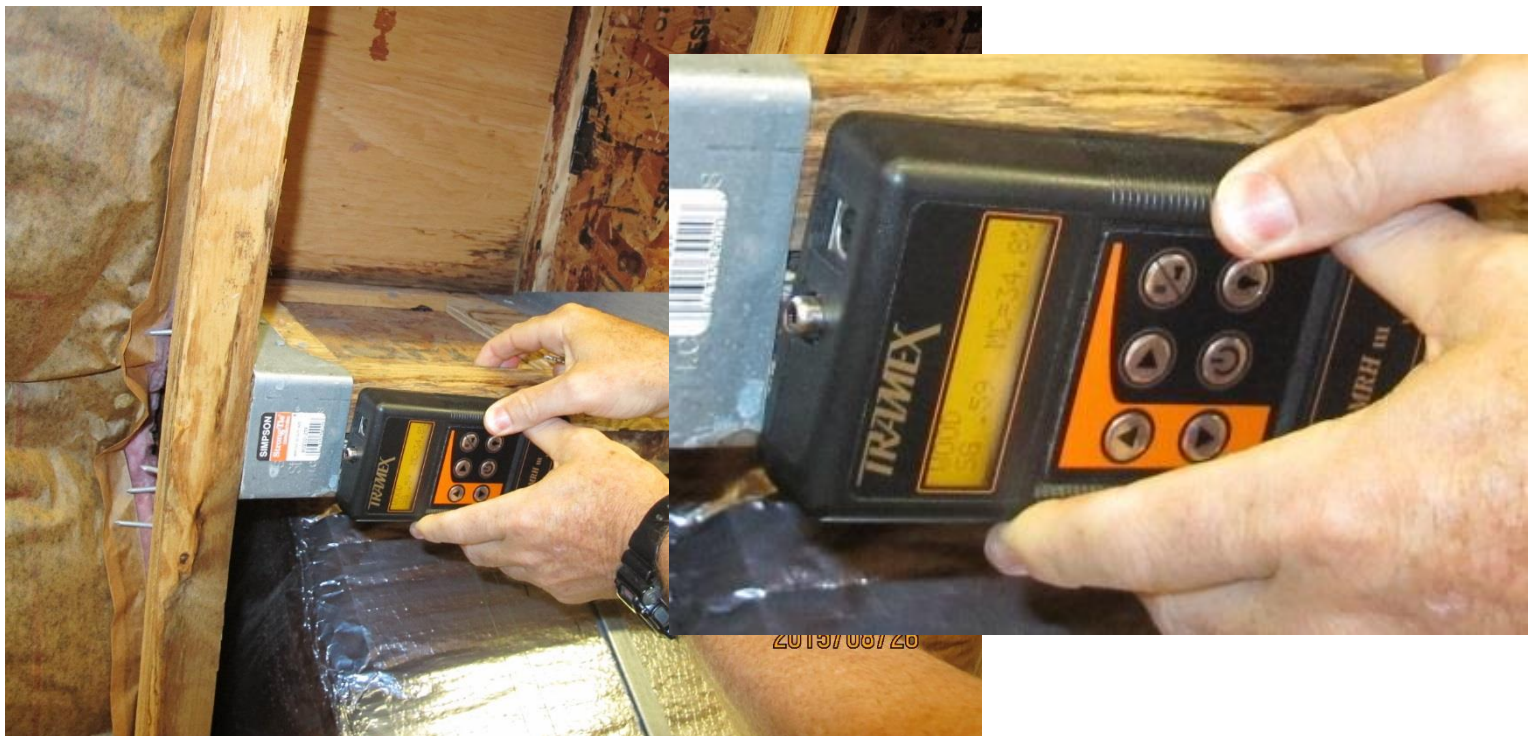
Elevated MM reading of 34+% MC indicating a still active leak associated with exhaust penetration

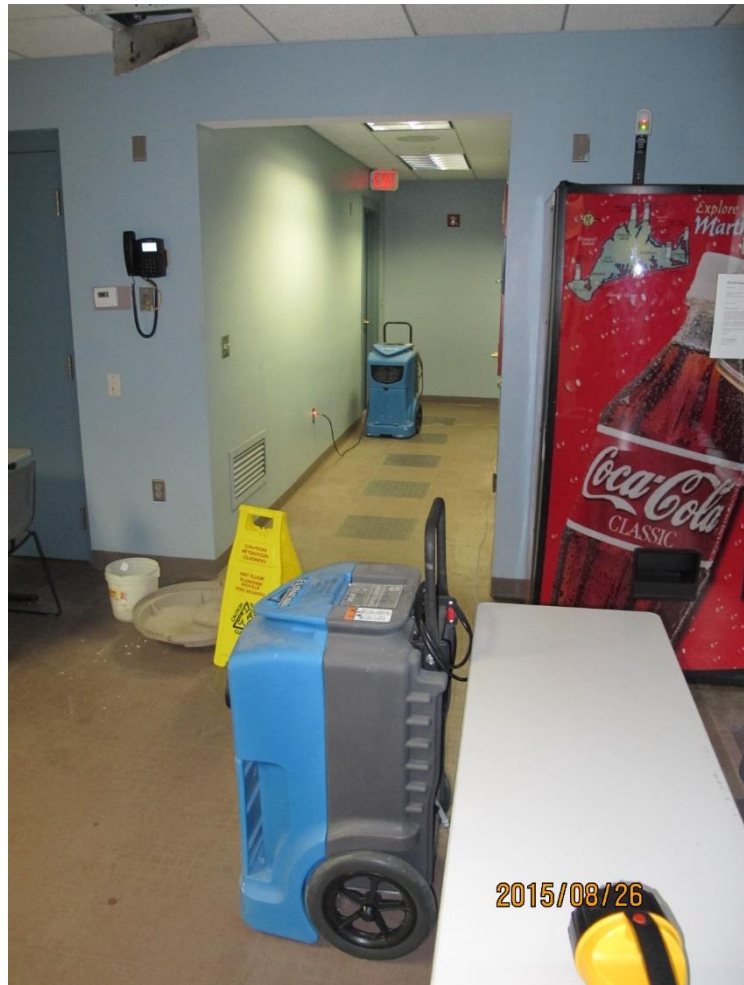
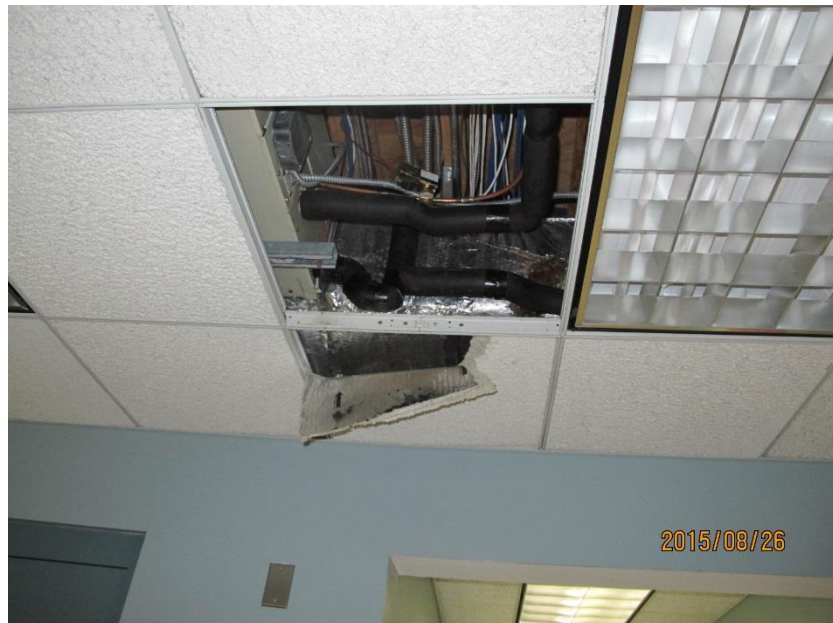
Ceiling leak in Briefing Room

- There were dirt streaks across the drop ceiling tiles (DCTs) near supply grates (see photos), indicating inadequate filtration of the supply air. [Replace affected DCTs AND locate and replace the air handler filter with a proper sized pleated media now and on a quarterly basis.]
- There were indications of several plumbing leaks above stained DCTs (see photos). [Ensure that the leaks have now been addressed or do so now and replace impacted DCTs.]

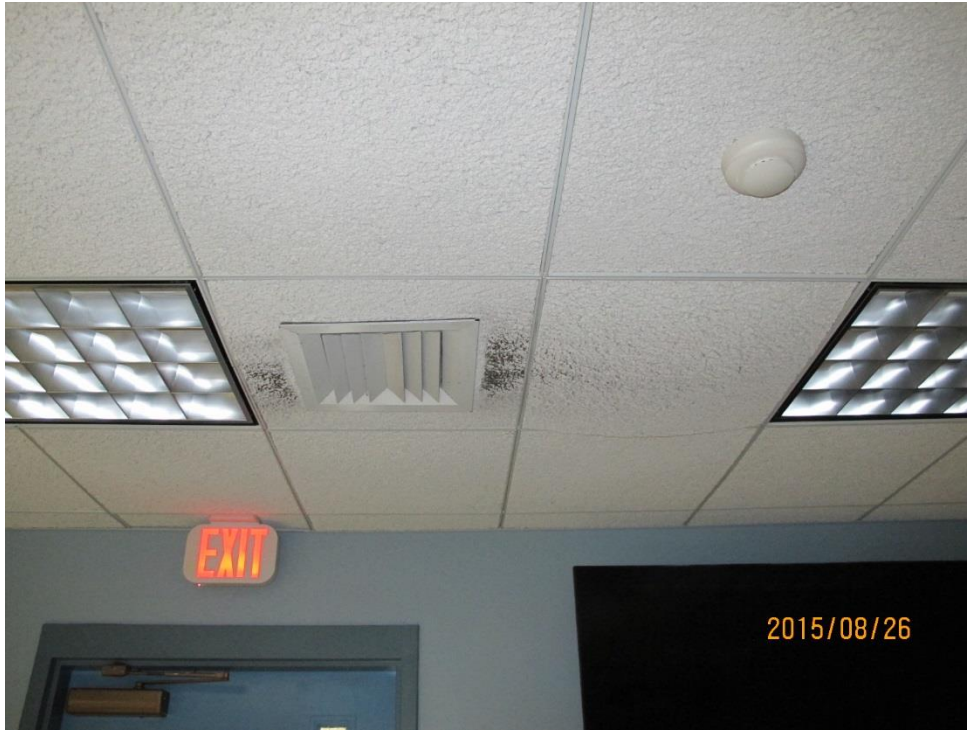
Dirt pattern on DCTs indicating ineffective air filter for air handler serving Briefing Room

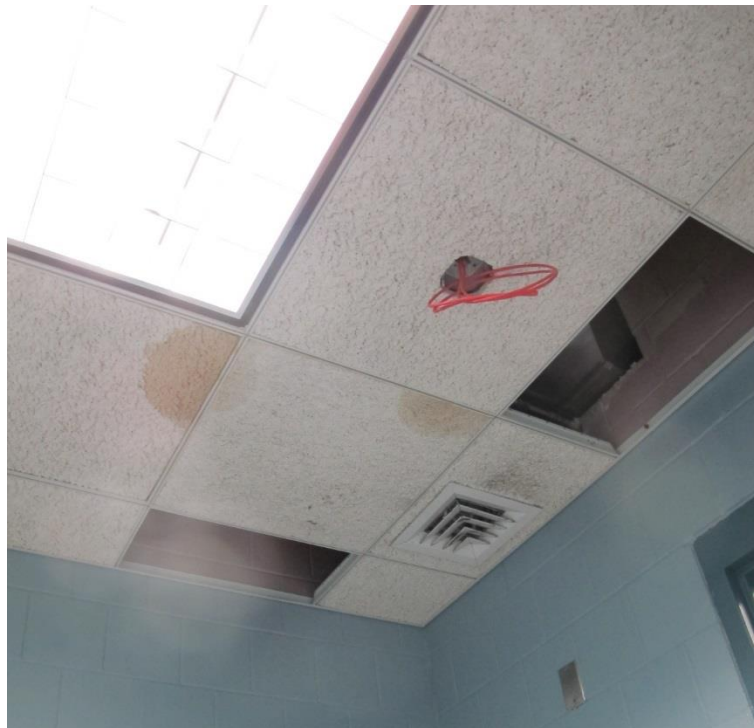
Indication of leaks in right  
interrogation room

- There were stained DCTs indicating plumbing leaks above stained DCTs (see photos). [Ensure that the leaks have now been addressed or do so now and replace impacted DCTs.]
- The supply grates were dirty (see photos). [Clean the grates AND locate and replace the air handler filter with a proper sized pleated media now and on a quarterly basis.]
