REPORT OF
CONDITIONS FOUND

M/V ISLANDER

Prepared For:

Turner Construction Company
10 South Street
Battery Maritime Building, Slip 7
New York, NY 10004

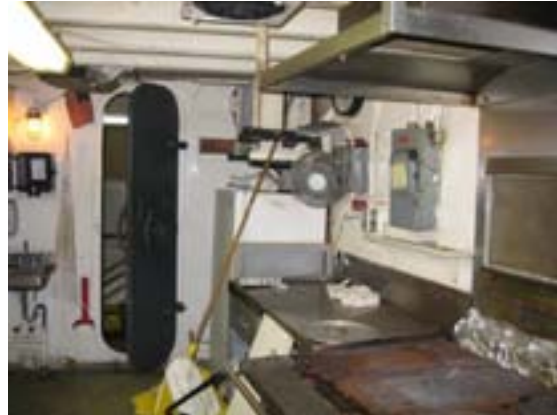
Water tight door

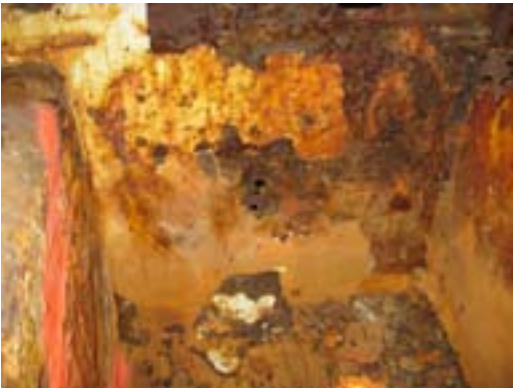
Holes in floors

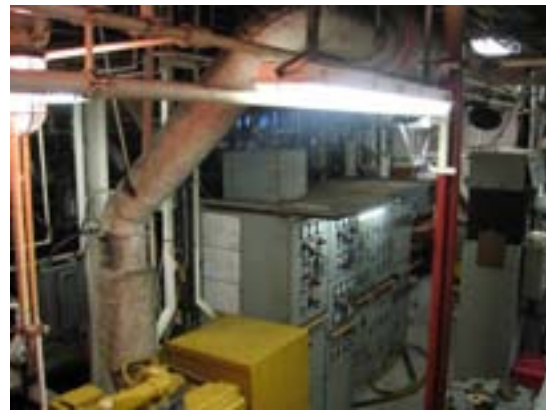
Main electrical distribution panels

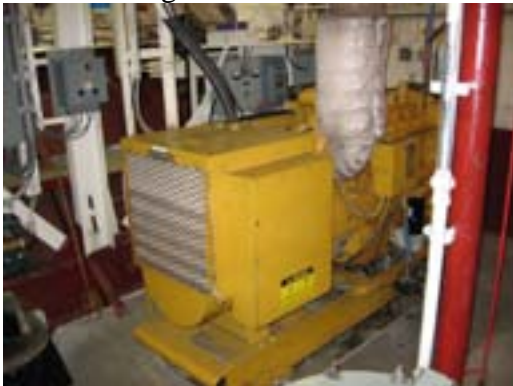
New AC Generator

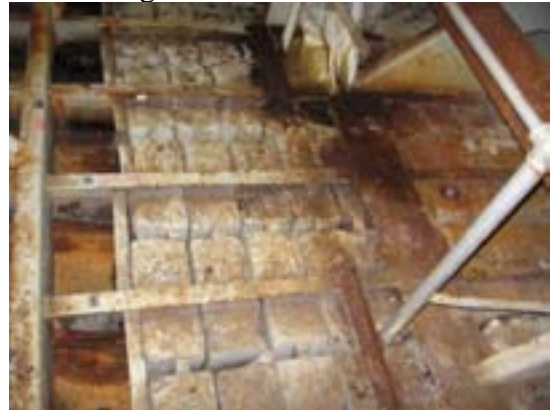
In the lower section of the space, many of the internals are wasted through. The bulkhead at frame #13 is severely corroded in the lower half at the shaft packing gland. Located in the center of the bilge is lead ballast. The plating and internals surrounding the ballast are in poor condition. The shaft and bearings appear to be in good working order.

Lead ballast blocks

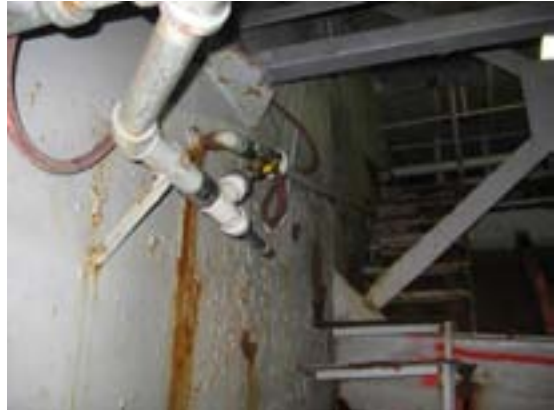
Access to this space is by the centerline trunk and an internal stairway. Compartment #5 is also the fuel tank room and has a 6,110 gallon fuel tank, another water tank and the aft shaft. This compartment has excessive coating failure, active corrosion and wasted steel. The bulkhead at frame #24 is buckled and severely wasted.

Wasted and buckled bulkhead #24 aft

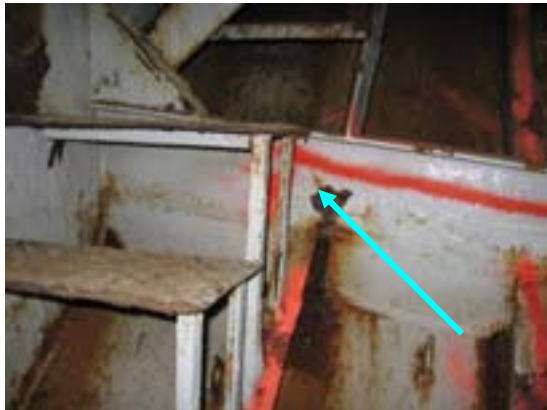
Hole in girder

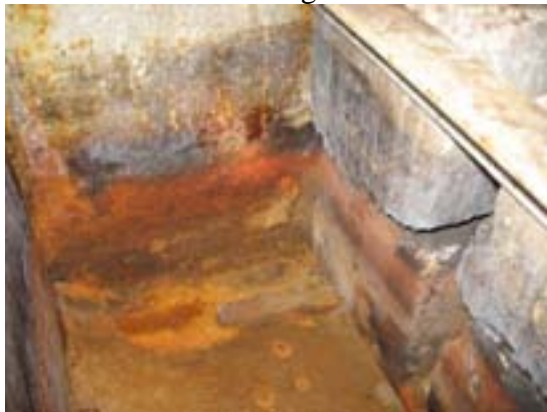
Wasted bottom plate next to lead ballast

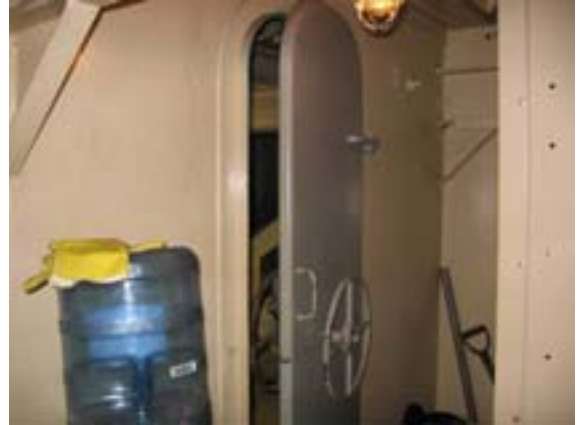
Watertight door in Bulkhead #36 aft

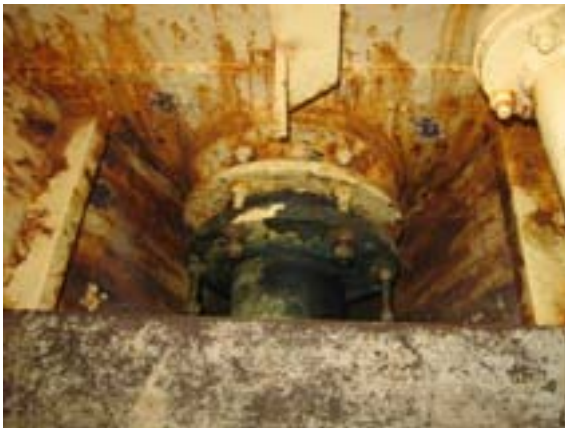
Wasted Steel bulkhead #47 aft

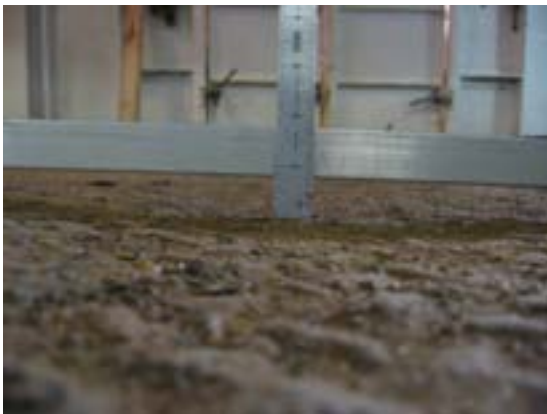
Buckled down – 13/16" depth

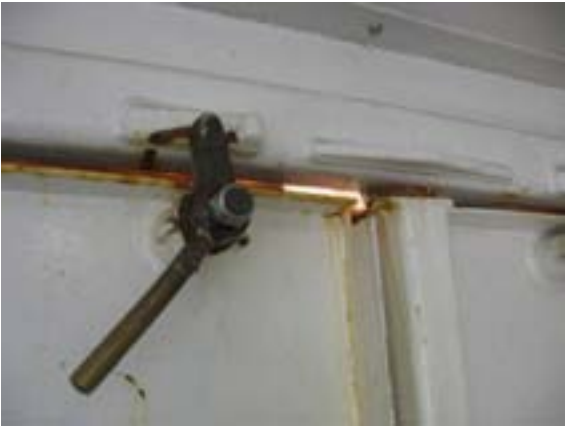
Watertight loading door will not close

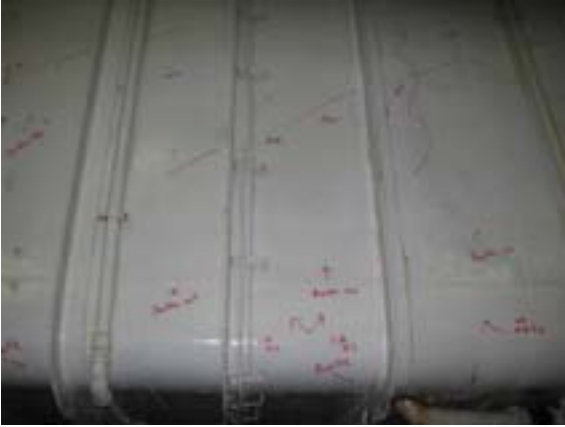
The interior longitudinal bulkheads are significantly buckled with cracked welds in many of the frames. Each gusset at the main deck stanchions is buckled. The coatings have been renewed and are in fair condition. The deck is holed at the toilets and sinks.

Buckled bulkhead - starboard midship

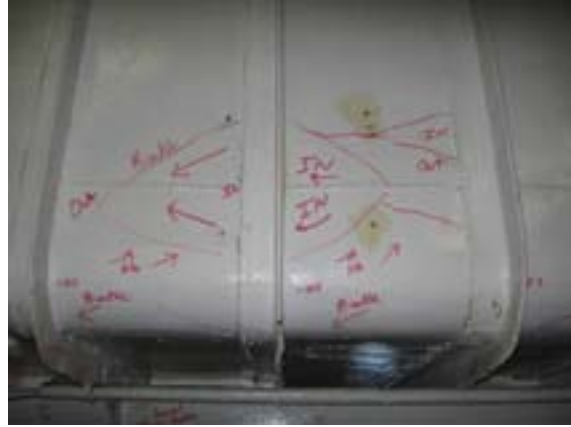
Buckled bulkhead - starboard aft

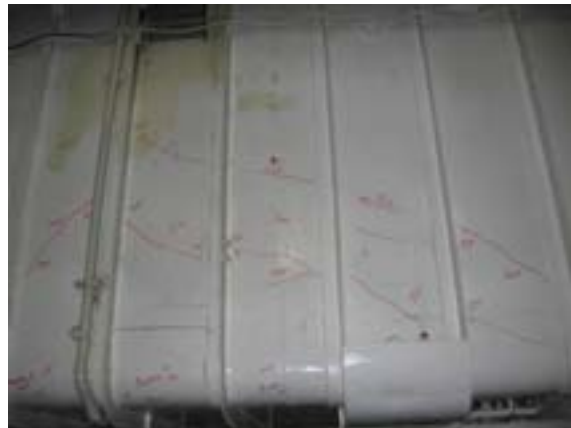
Buckled bulkhead - port midship

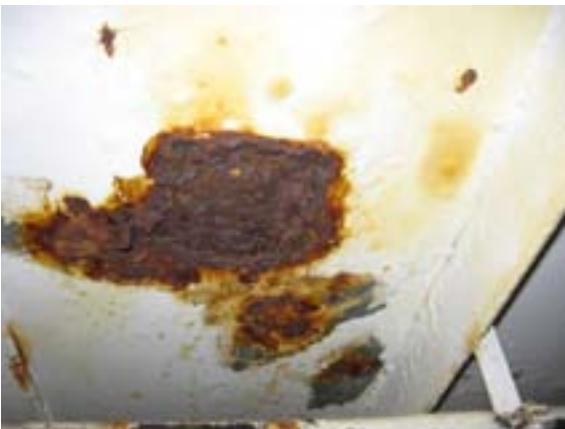
Deck wasted through in head at sink

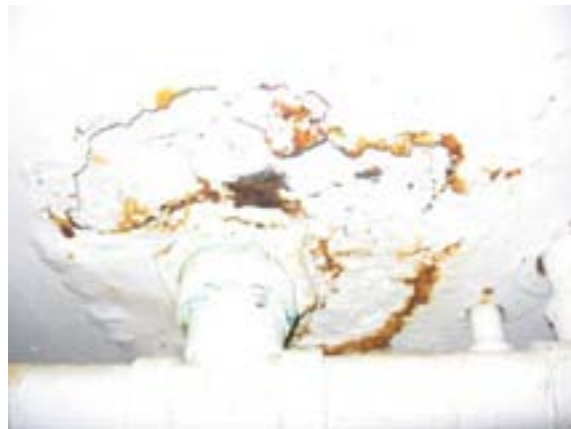
Deck wasted through at toilets

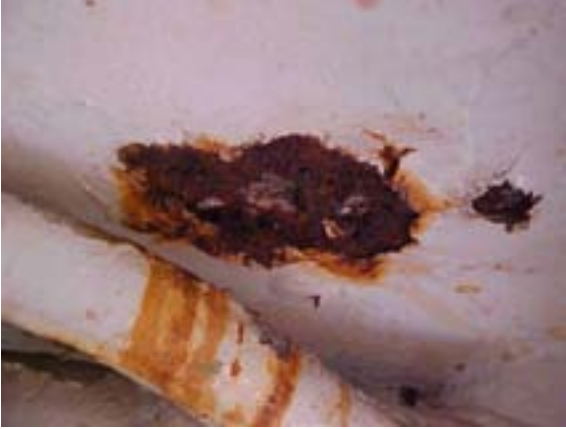
Wasted steel in salon deck

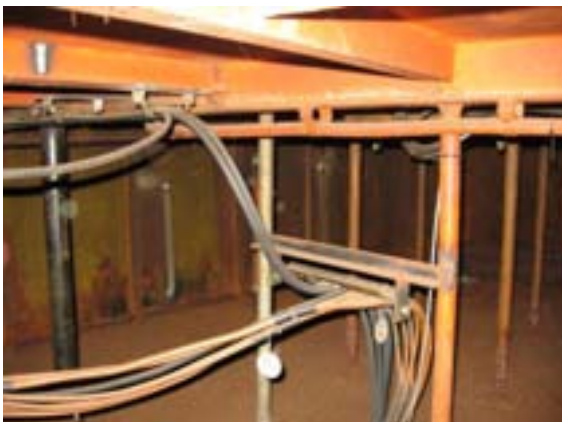
There is a void space underneath the wheelhouses that is accessed by a hatch in the wheelhouse deck. These spaces have significant coating failure and active corrosion as a result of water lying in the space.

Corroded steel and coating failure
