Accessibility Survey

Town of Tisbury School

40 West Williams Street Vineyard Haven, MA 02568

Date of Inspection 5/6/2019

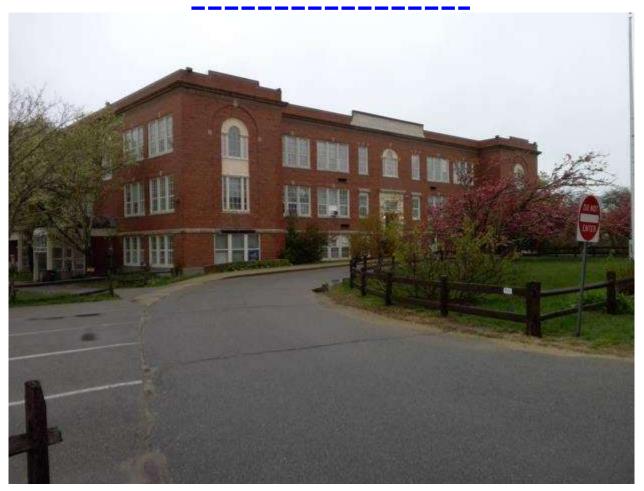
Path of Travel - 1st Floor : Path Of Travel , Walking Surfaces

1st Floor Main Entrance

Step

There is a step or curb on the path of travel preventing access.

Provide a ramp or other means of vertical access.

Path Of Travel , Walking Surfaces : Stairs or Steps Obstruction

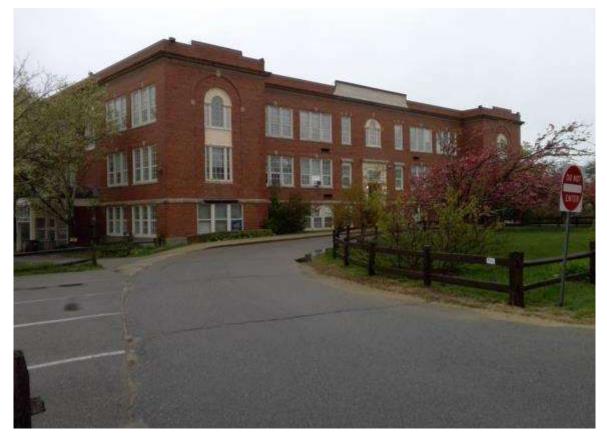
Signage $\,:\,$ No Room Identification
