REPORT OF
CONDITIONS FOUND

M/V ISLANDER

Prepared For:

Turner Construction Company
10 South Street
Battery Maritime Building, Slip 7
New York, NY 10004

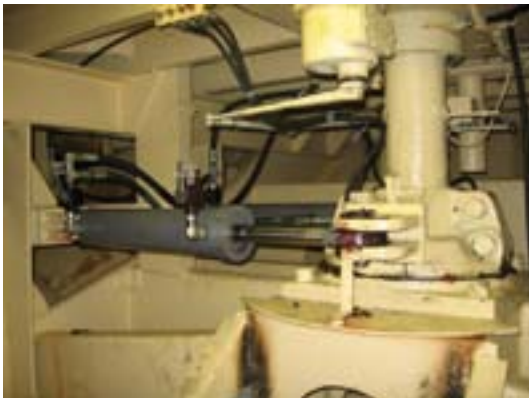
The steering gear is located in this compartment. The steering cylinders appear to be fairly new and in good working condition. The rudder post and upper bearing appear to be in good condition. There is evidence of salt water leaking through the rudder post.

Forward Steering cylinders

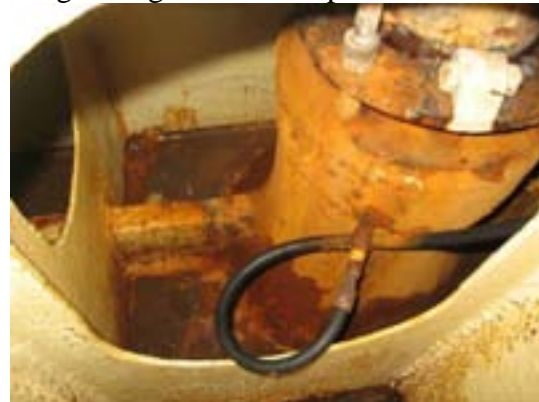
Rudder Post

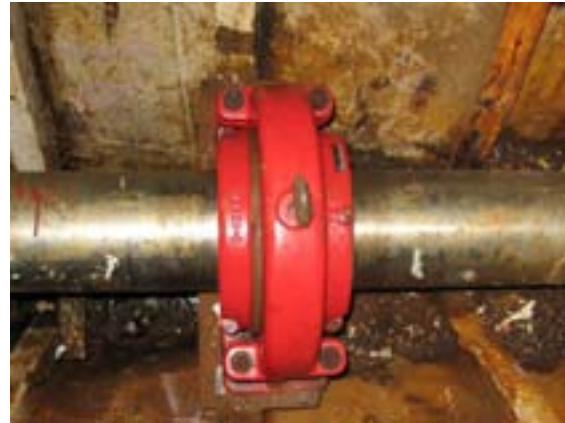
Shaft bearing

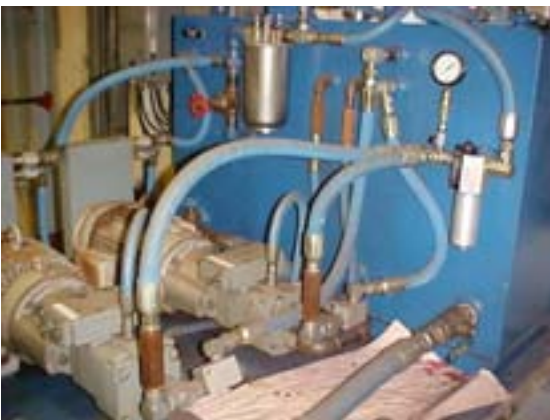
Forward Steering motors

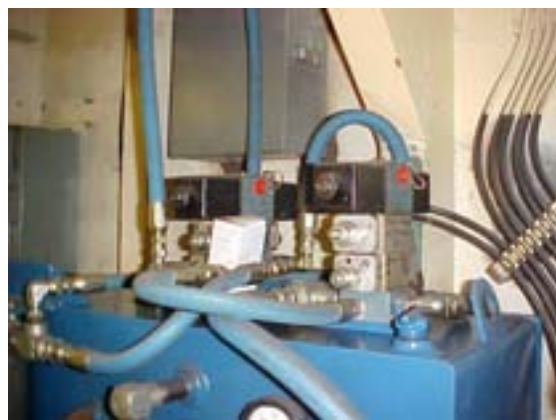
Steering Control Solenoids

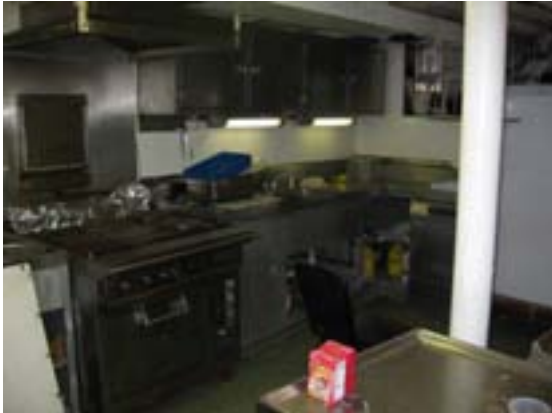
Galley

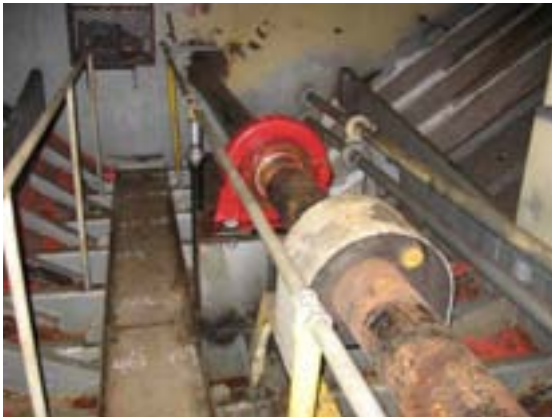
Forward Shaft

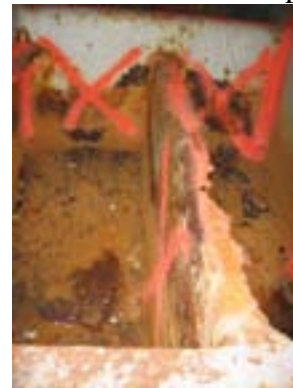
Wasted web frame

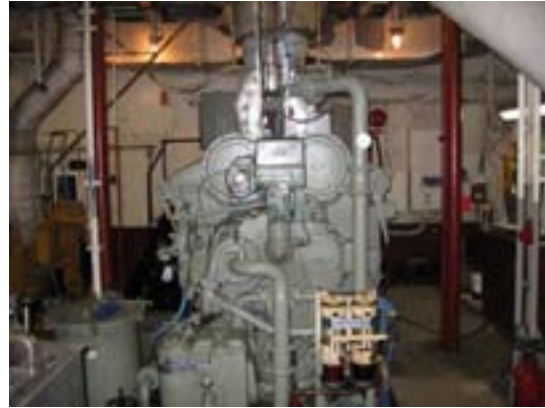
Main Engine

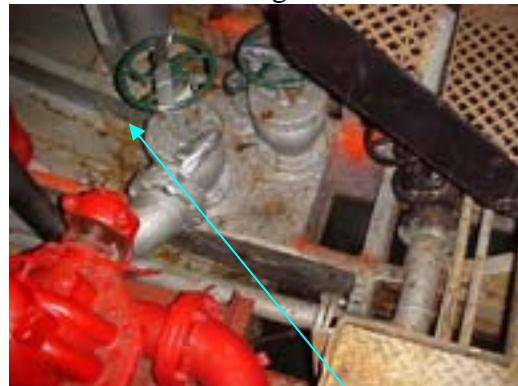
Seachest – Hole in frame

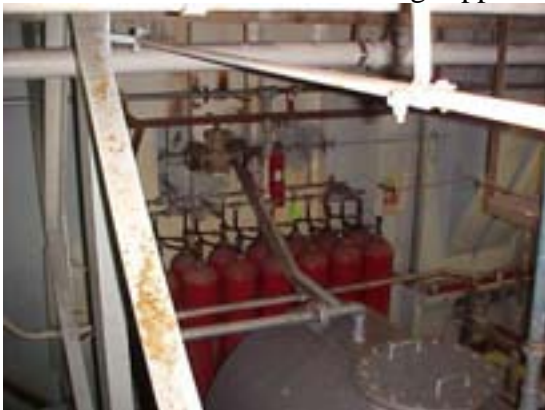
CO2 system

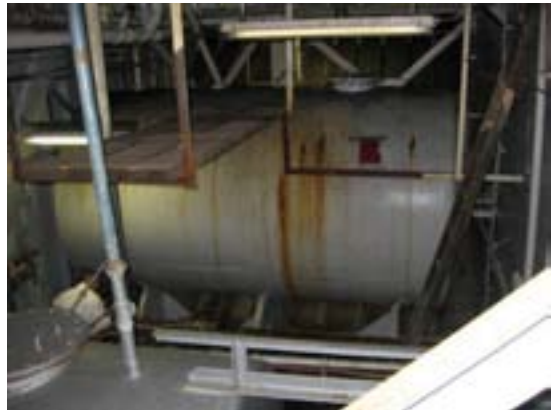
Fuel Tank

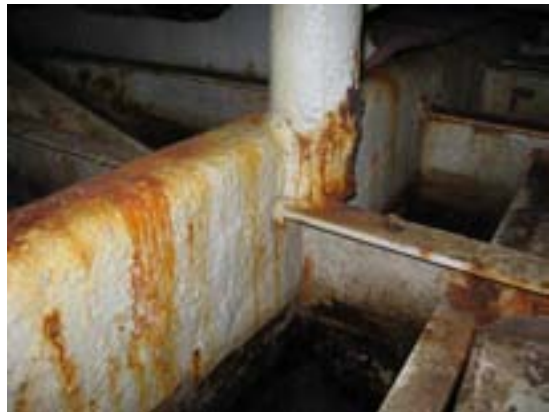
Wasted girder

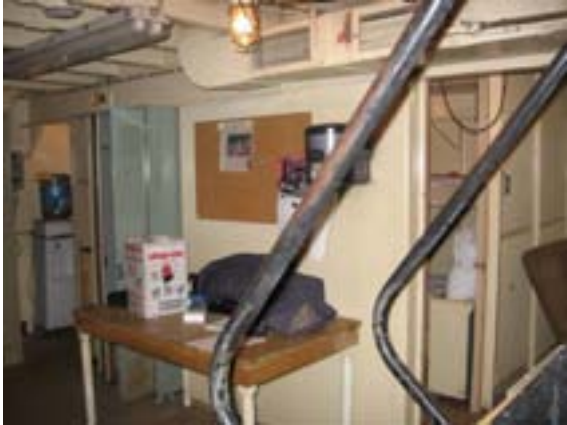
Berthing Area

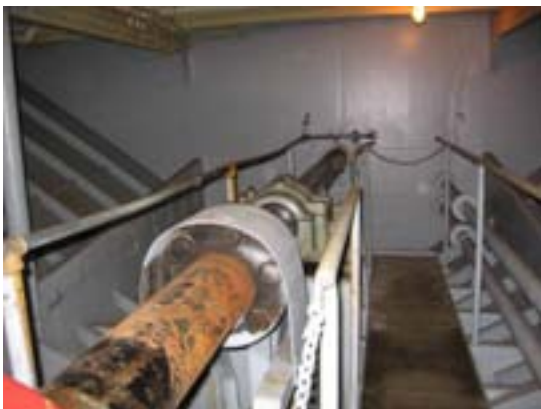
Aft shaft and bearing

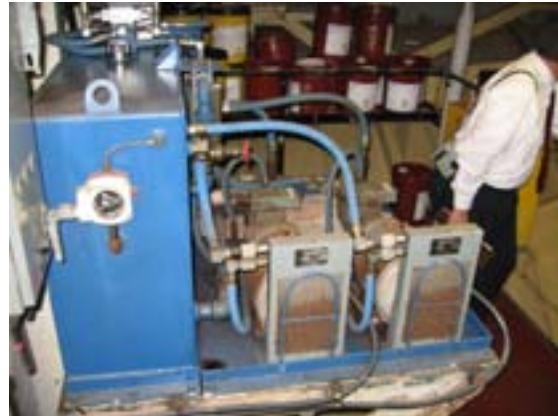
Aft Steering motors

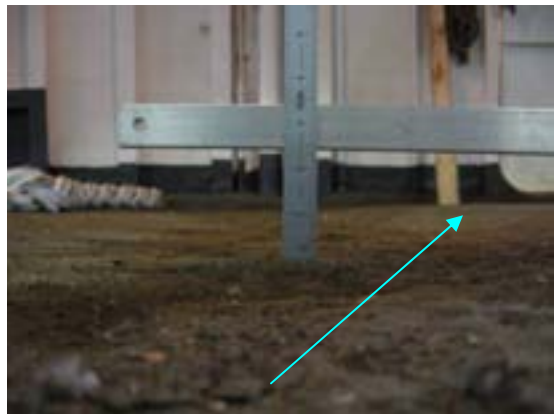
Buckled up 1-1/2"

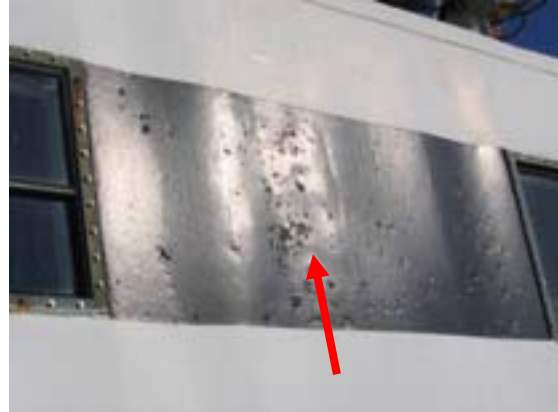
Deep pitting

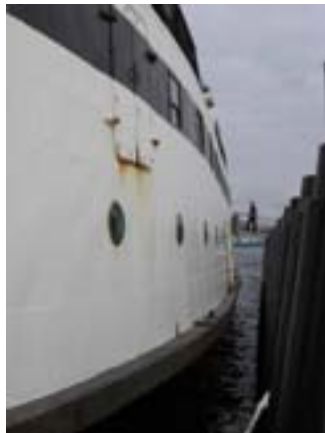
Passenger loading doors

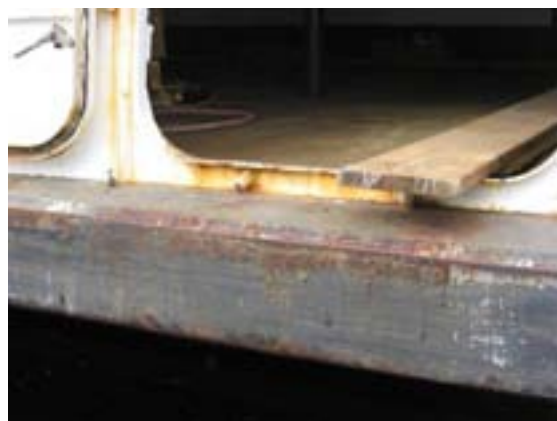
Midship cargo doors

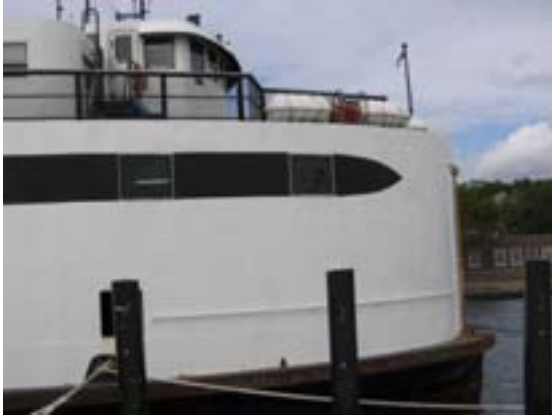
Superstructure

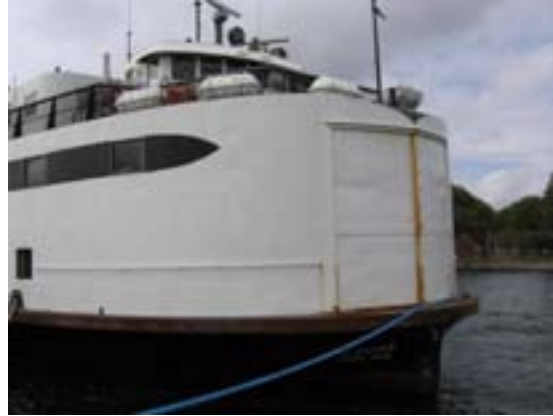
Bow loading doors

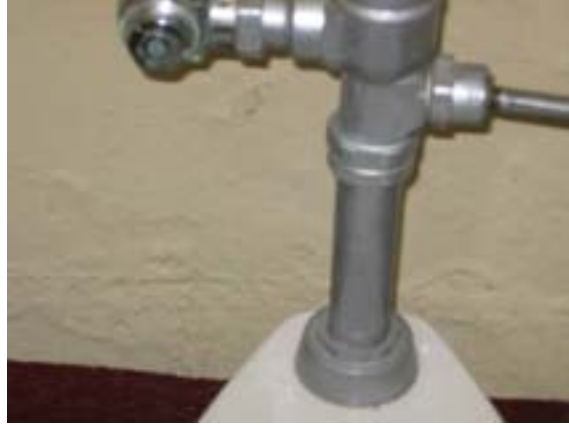
Wasted plate in heads

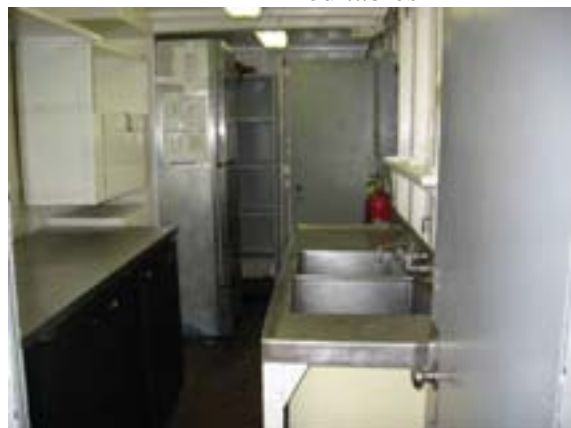
Hole in boat deck under salon

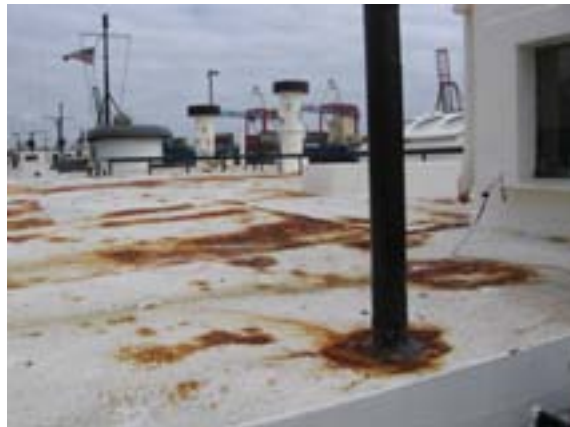
These areas are in fair condition. The showers have corroded steel in them. Under each of the port holes, the bulkheads are wasted and holed. The coatings are fairly intact. The housetops are corroded and have significant coating failure.

Housetop

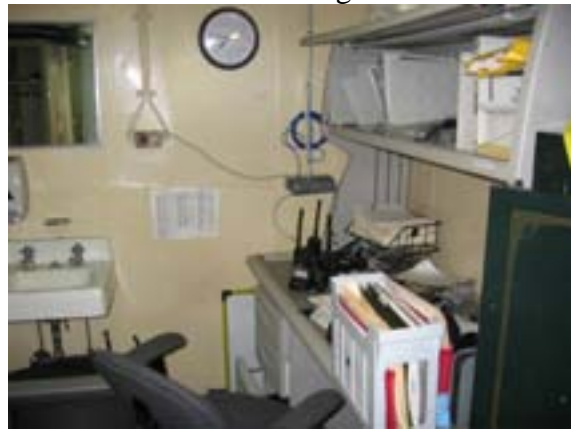
Hole in bulkhead under porthole

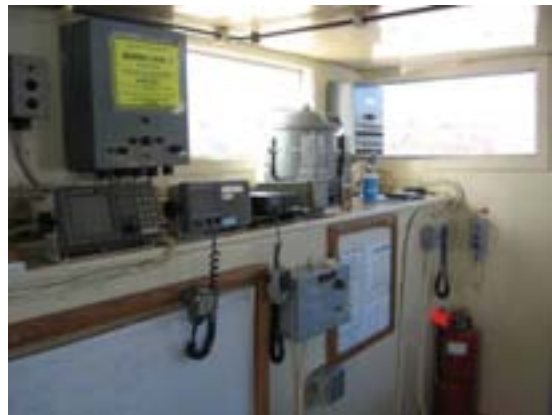
There is a void space underneath the wheelhouses that is accessed by a hatch in the wheelhouse deck. These spaces have significant coating failure and active corrosion as a result of water lying in the space.

Void space under wheelhouse
